# Service Bulletin

Bulletin No.: 09-07-30-004J

**Subject:** Slips in Reverse or Third, Delayed Reverse or Drive Engagement, DTC P0776, P2715, P2723, Harsh 2-3 Shifts (Inspect 1-2-3-4 / 3-5-R Housing and Pump Seal Rings)

**Models:** 2006-2009 Cadillac STS-V, XLR, XLR-V  
2007-2008 Cadillac Escalade, Escalade ESV, Escalade EXT  
2006-2009 Chevrolet Corvette  
2007-2008 Chevrolet Silverado  
2008 Chevrolet Suburban  
2007-2008 GMC Sierra, Sierra Denali, Yukon Denali, Yukon XL Denali  
2008 GMC Yukon XL  
2008-2009 HUMMER H2  
2008-2009 Pontiac G8  
Equipped with 6L80 or 6L90 Automatic Transmission (RPOs MYC, MYD)

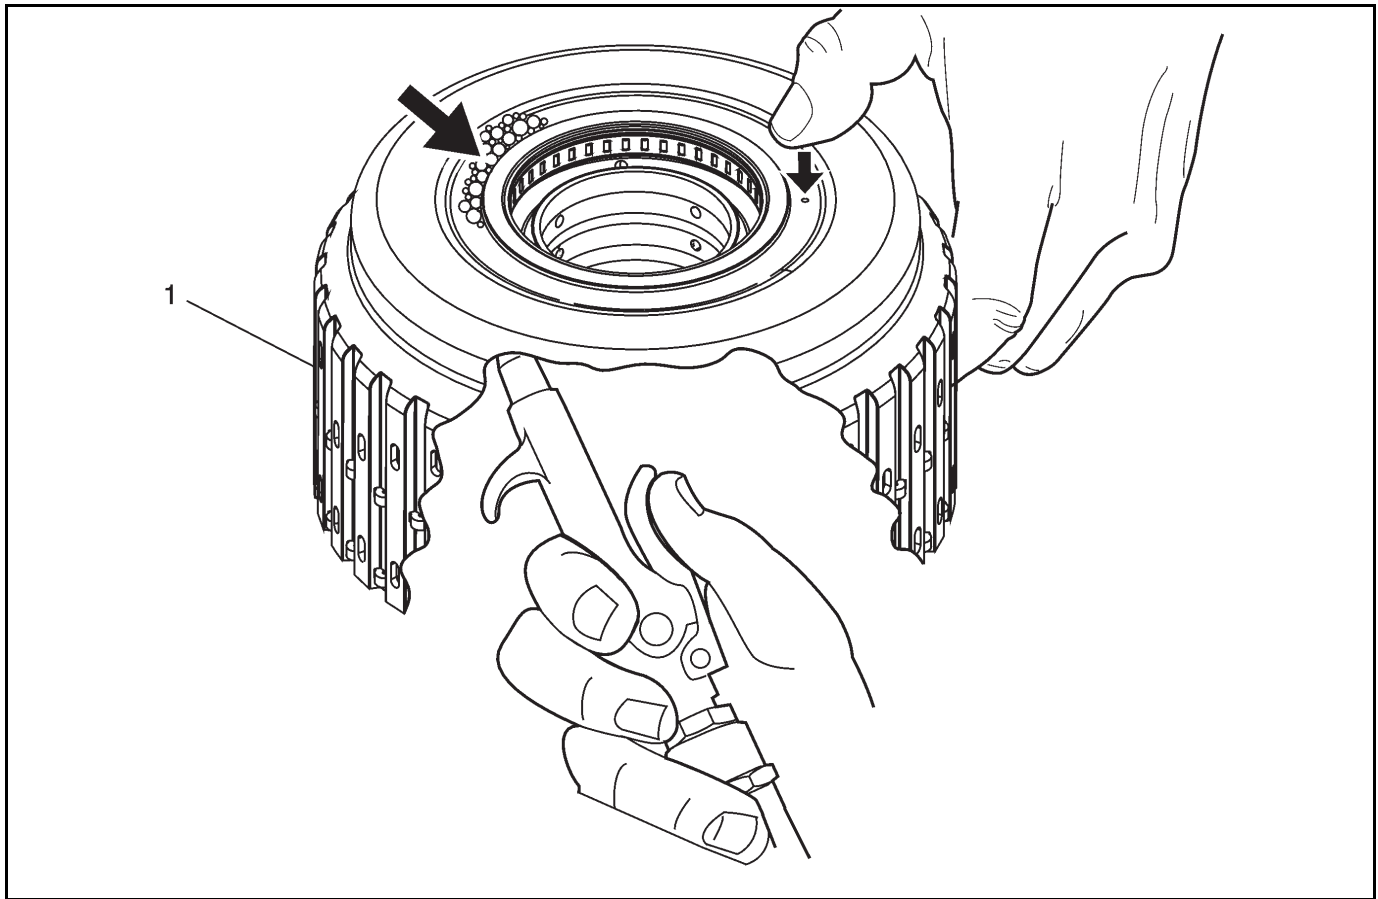
2539550

Inspect the 1-2-3-4 / 3-5-R clutch housing for a possible cracked weld.

1. Apply soap compound to weld area of the housing.
2. Hold your thumb over the air bleed passage.
3. Spray compressed air into the housing and inspect the weld area for bubbles.
4. If bubbles are detected, a new housing is required.

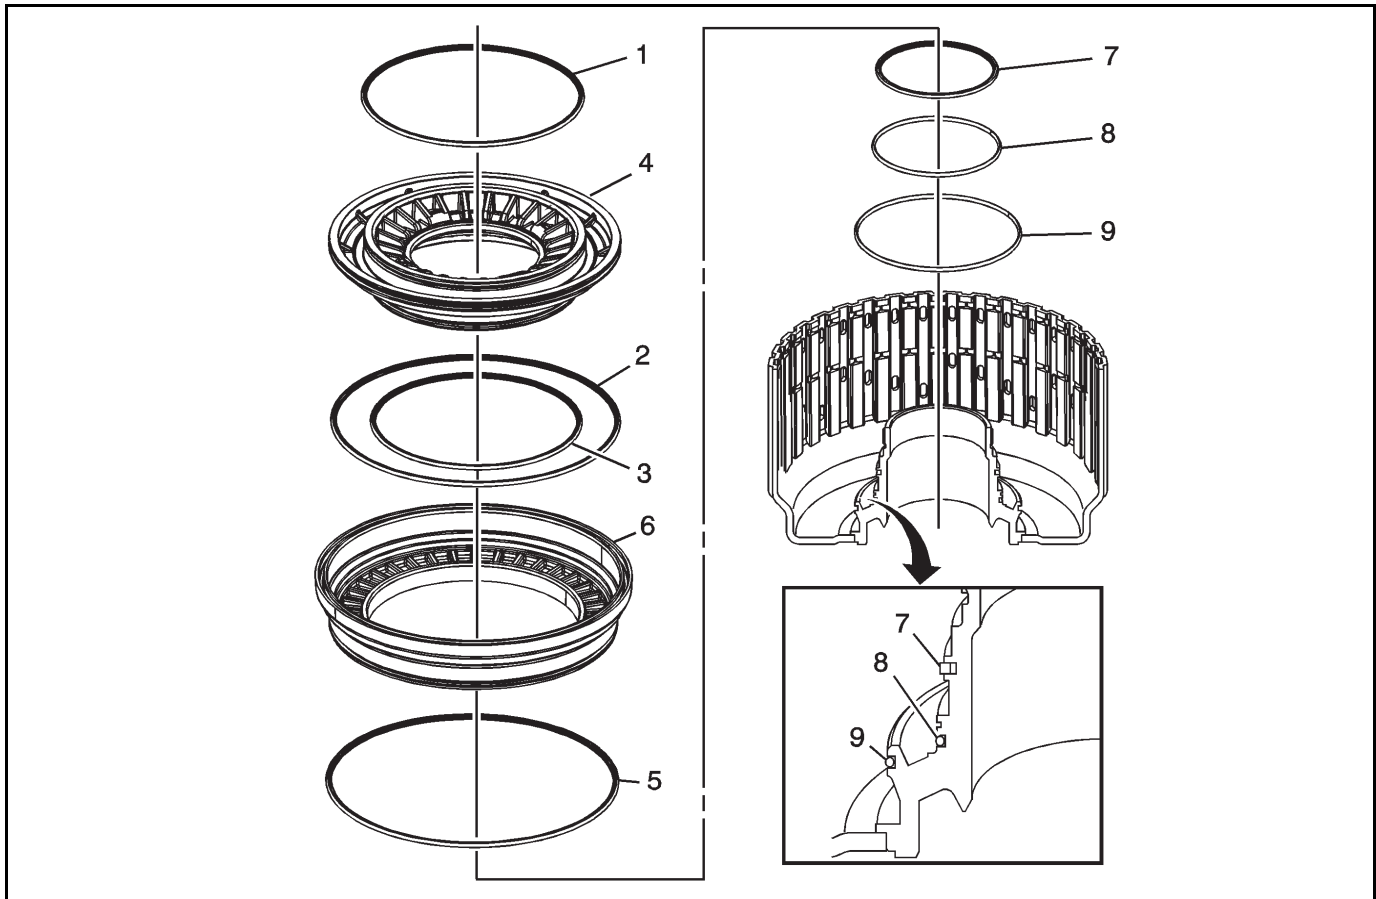
**Important:** The 6L80 transmission had a design change to the 1-2-3-4 piston, 1-2-3-4 piston housing and the 3-5-R piston for the 2008 model year. Installation of a 2008, 6L80 complete housing assembly into a 2007 or older 6L80 may result in a 2-3 shift flare or 3-5-R clutch distress.

**Important:** When installing a new 1-2-3-4 / 3-5-R housing into a 2007 or older 6L80, be sure to install all three (3) inner seals (7, 8, 9 in illustration below). Failure to install these seals can result in no reverse, no forward or distressed clutches.

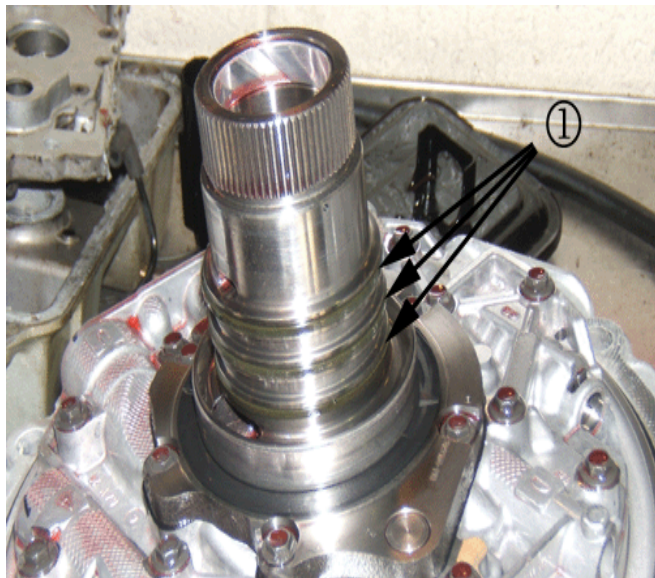
2219005

A harsh 2-3 shift condition may be caused by leaking 1-2-3-4 and 3-5-R clutch fluid seal rings (1) on the transmission fluid pump cover assembly.

Inspect the fluid seal rings. Transmissions in 2006, 2007, 2008 and early build 2009 models used a 1- piece design seal ring in production. Starting December 2008, a 2-piece seal ring design was implemented. The 1-piece seal ring design may cause a harsh 2-3 shift due to leakage. This is typically a low mileage issue. If the seal rings are a 1-piece design they should be replaced with new 1-piece design seal rings. It is not necessary to replace the pump cover.

**Notice:** The clutch fluid seal rings must be installed in a specific way. Failure to install new clutch fluid seal rings in the proper orientation may cause a repeat harsh 2-3 shift. Refer to 1-2-3-4 and 3-5 Reverse Clutch Fluid Seal Ring Installation (6L80/90) in SI for correct installation.

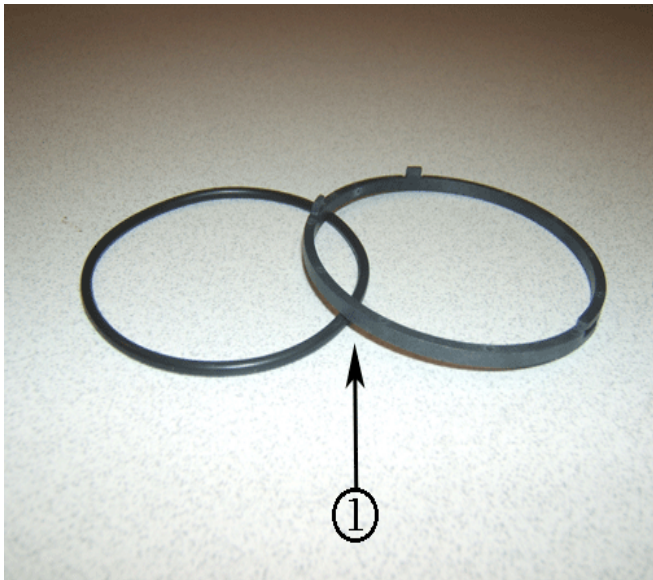
2475192

If the seals are the 2-piece design shown below, they do not need to be replaced unless they are worn or damaged.

**Important:** Do not install 1-piece design seal rings on a 2-piece seal ring design pump cover. The 2-piece seal ring design pump cover can be identified by the notch in the seal ring grooves that accepts the tab on the 2-piece design seal rings.
