Service Bulletin

Subject: Front Seat Lateral Movement and/or Click Type Noise While Driving

Models: 2014 Chevrolet Silverado 1500
2014 GMC Sierra 1500

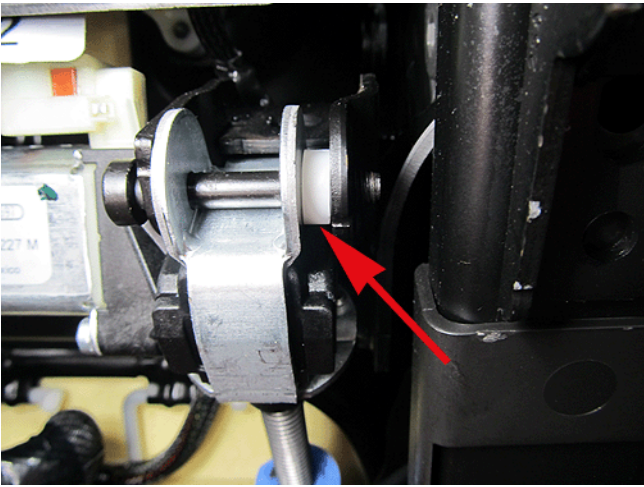
This condition may be caused by movement in the seat cushion and/or movement between the seat pan front pivot points and the seat frame. The plastic attachment points may “stick” then “slip” creating the condition. There may also be excessive clearance between the power seat vertical adjuster actuator and the attachment point on the seat frame.

22. Locate the power seat vertical adjuster actuator attachment to the seat frame.

23. Install the shim clip as shown.

It may be necessary to slightly spread the bracket on the seat frame with a large screwdriver to allow clearance for the clip.
