Service Bulletin

Bulletin No.: P11004A

Subject: Malfunction Indicator Lamp (MIL) On, Service StabiliTrak, Power Steering or Vehicle Soon Message Displayed on DIC

Models: 2012-2014 Chevrolet Equinox
2012-2014 GMC Terrain
Equipped with 2.4L Engine (RPO LEA)
and Built Prior to October 1, 2013

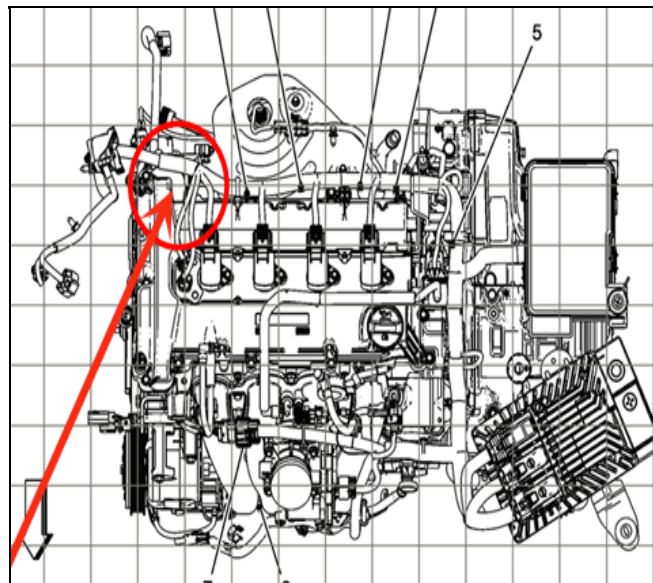
These conditions may be caused by one of the wires (in particular circuits 2500 and 2501) in the engine wiring harness being chafed, cut or damaged due to contact with the right rear corner of the engine or cam/valve cover.

Repair the affected wire. Inspect other wires in the bundle for chafes and repair if needed. Wrap the harness with Woven Polyester Electrical Tape (PET) (preferred) or equivalent anti-abrasion tape as the image shows and route the harness away from the suspect areas of engine component contact to prevent the wiring from chafing through again.
