# Service Bulletin

Bulletin No.: P11294

**Subject:** Intermittent Service Power Steering Message Displayed on DIC, DTC C056D, C0475 or U0131 May Be Set

**Models:** 2012-2014 Buick LaCrosse  
2014 Buick Regal  
2014 Cadillac XTS  
2014 Chevrolet Impala  
Equipped with Belt Drive Electronic Power Steering (RPO NJ2)

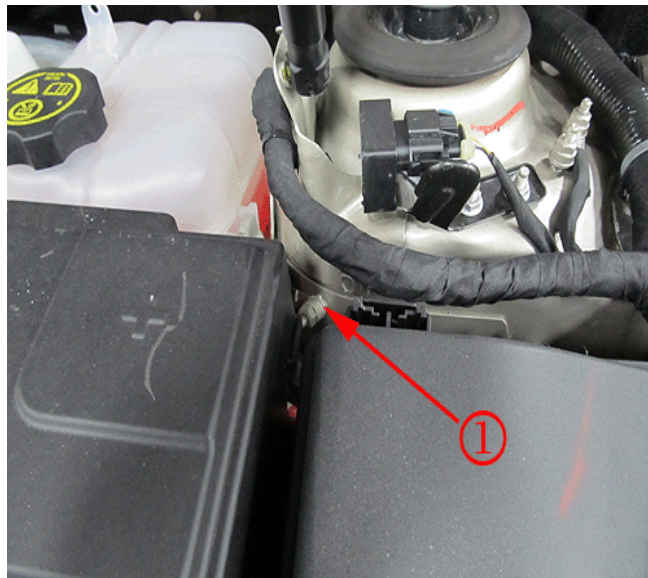
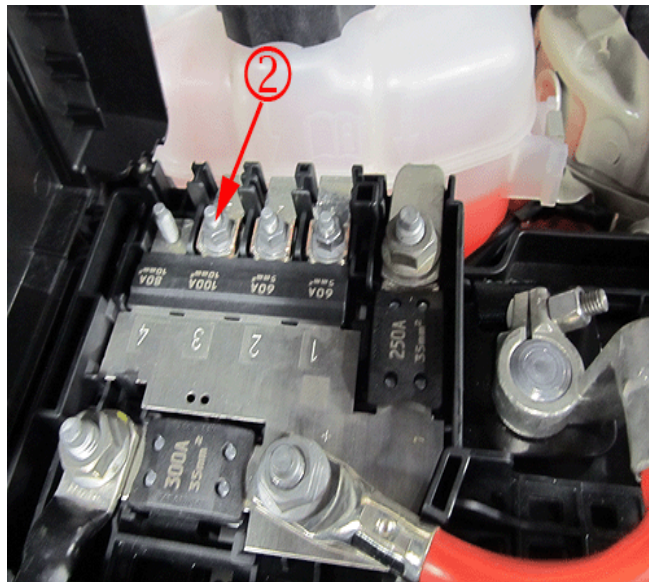
3775857

1. Inspect the G111 ground (1) and the 100A F3UB fuse (2) for proper connection. Ensure the ground is free of paint and both connections are tight.

- Tighten the G111 ground to 9 N•m (80 lb in).
  - Tighten the F3UB fuse to 4.7 N•m (42 lb in).
2. Fully charge the battery using the GR-8 Tool (EL-50313).
  3. Reprogram the power steering control module using the Service Programming System (SPS) with the latest calibrations available on TIS2WEB. Refer to the Power Steering Control Module Programming and Setup (NJ2) procedure in SI.
