# Service Bulletin

Bulletin No.: 06-06-01-007H

**Subject:** Information On Identifying Duramax™ Diesel Overpower Engine Breakdown or Non-Function Due to Aftermarket Power-Up Devices vs. Non Overpower Engine Non-Function of Pistons, Cylinders, Valvetrain Components, DTC P003A or P111D Set

**Models:** 2001-2015 Chevrolet Silverado  
2003-2009 Chevrolet Kodiak  
2006-2015 Chevrolet Express  
2001-2015 GMC Sierra  
2003-2009 GMC TopKick  
2006-2015 GMC Savana  
Equipped With Duramax™ Turbocharged Diesel Engine RPO LB7, LBZ, LLY, LML, LMM, or LGH

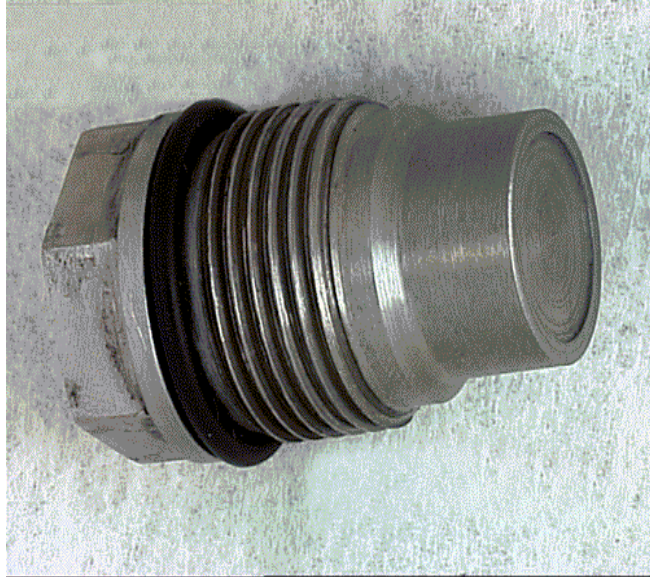
2159724

Aftermarket companies have developed a performance pressure relief fuel valve for Duramax™ diesel engines. Refer to above graphic illustration. The performance pressure relief fuel valve attaches to the fuel rail in place of the OEM valve and will not allow any fuel return to the tank, giving 100% of the fuel to be available for additional engine performance. This may cause additional fuel related driveability concerns and may set the following DTCs:

- DTC P1093 Fuel Rail Pressure (FRP) Low During Power Enrichment
- DTC P0087 Fuel Rail Pressure (FRP) Too Low

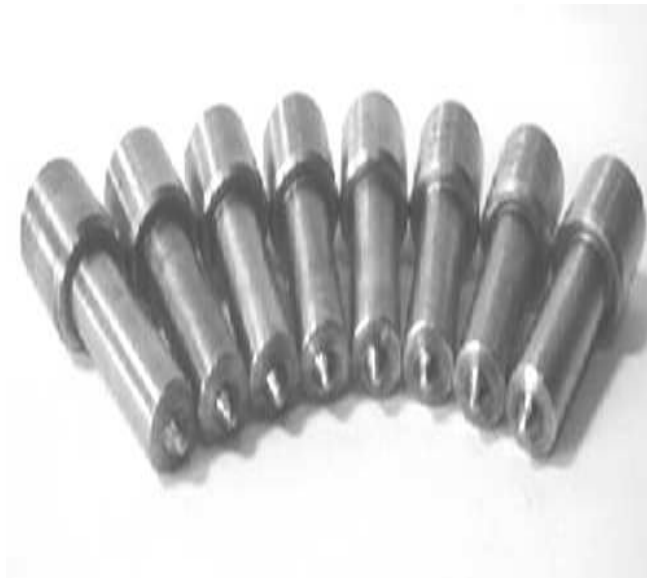
2160302

Aftermarket companies have developed a replacement performance/economy fuel injector nozzle. Refer to above illustration. The performance/economy fuel injector nozzles replace the OEM fuel injector nozzles. The aftermarket companies claim increased horsepower, improved fuel atomization, lower exhaust gas temperatures and increase fuel economy. This may cause additional fuel related driveability concerns and may cause internal engine damage to the pistons and fuel injector nozzles.

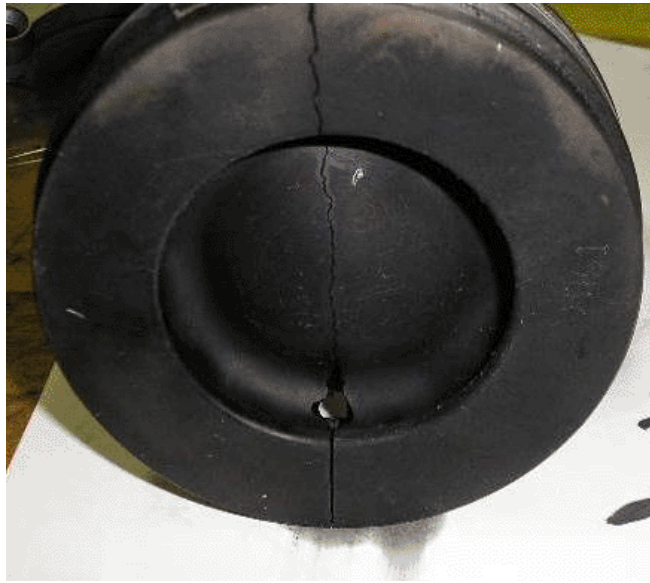
1771277

- Pistons will be cracked in the lip area, or a hole in the pistons.

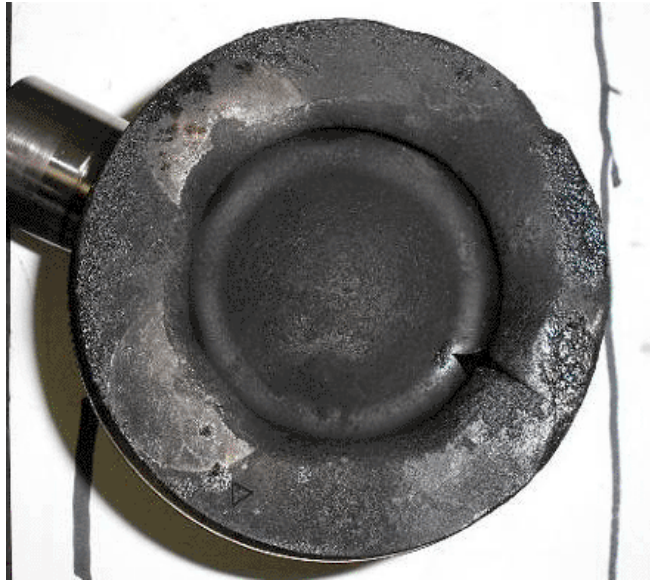
1771279

- Pistons can also be melted on the lip of the combustion bowl, or the top of the pistons can be melted.

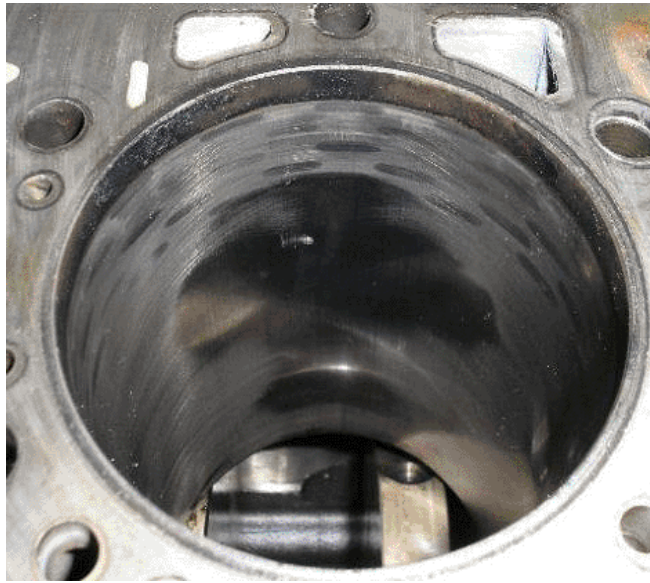
1771281

- Crosshatch will be polished off the cylinder wall in the major thrust face of cylinder below ring belt travel.

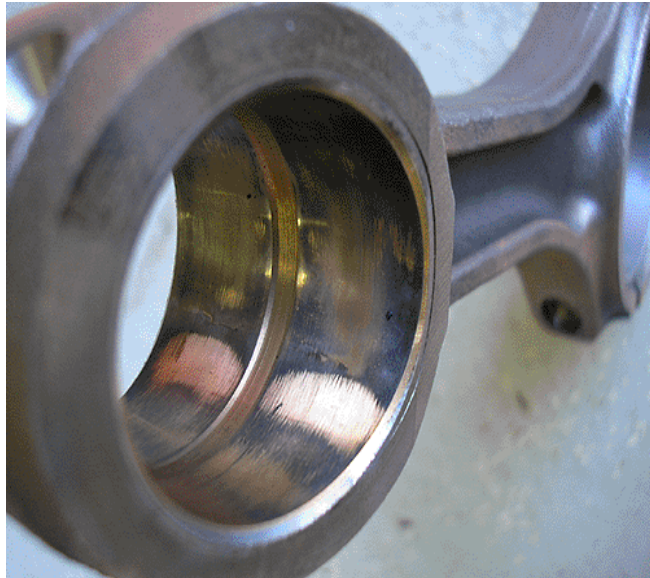
1806909

- Piston pin bore will show signs of scoring, the wrist pins will be discolored, and can have oil coking on them. The connecting rod bushing surface will have accelerated wear. The above illustration shows a connecting rod bushing.

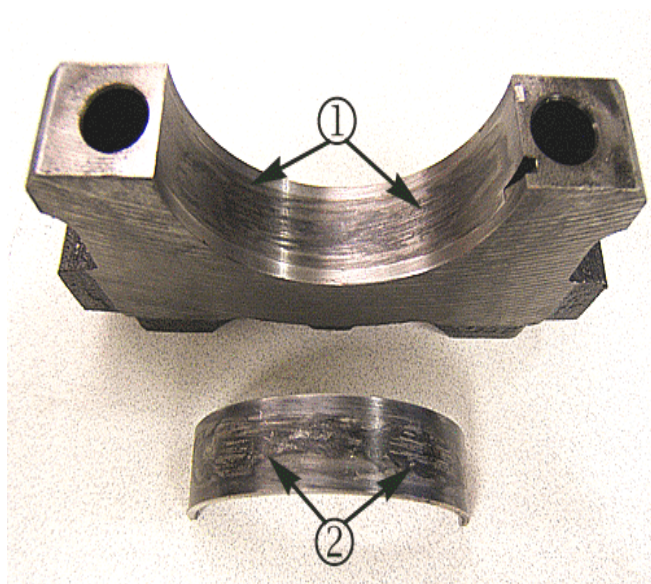
1797824

- Signs of bearing fretting will also be noticed on the connecting rod and main bearing caps. Refer to the above illustration for fretting of main bearing cap 1 and back side of connection rod bearing 2.

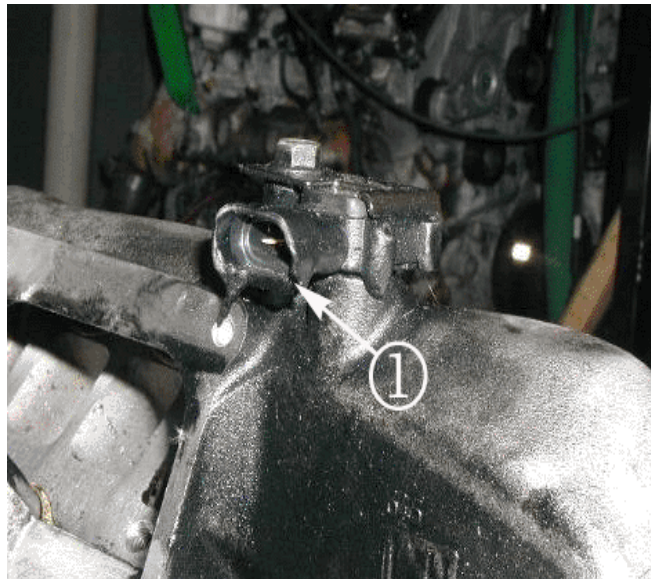
1771284

- Excessive heat in engine compartment caused by overpower device. Refer to above illustration (1).

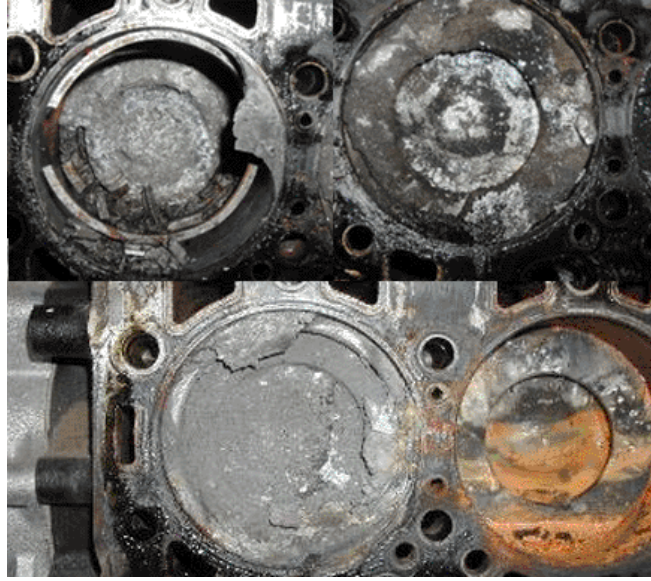
1771289

- Melted pistons.
- Head gasket breakdown or non-function.
- Warped cylinder heads.
- Crankshaft and connecting rod discolored.

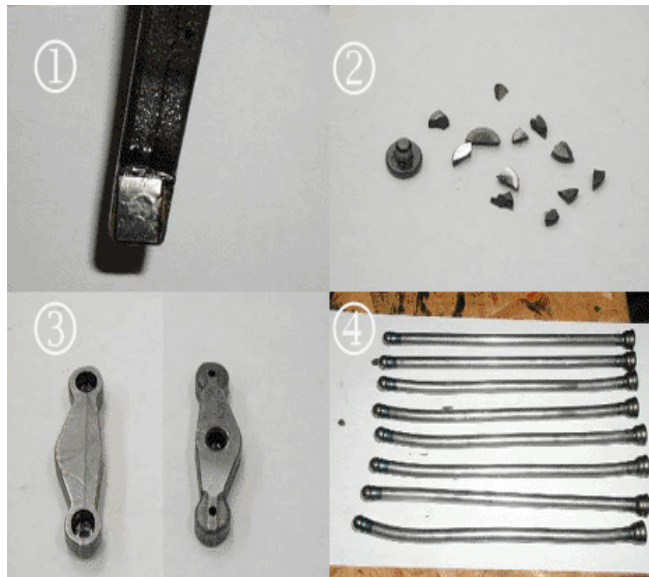
1771285

- Valve train damage.
- Pushrods that are bent (4).

- Broken valve bridge buttons after cylinder head removal (2).
  - Rocker arm tip damage (1).
  - Dry or rusted cylinders from the use of ether, propane or nitrous oxide.

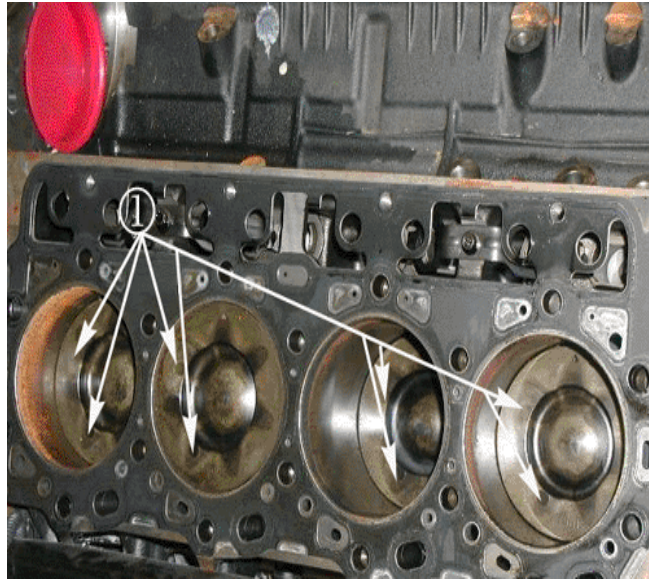
1771287

- Piston to valve contact.
- Cam gear pin shear.

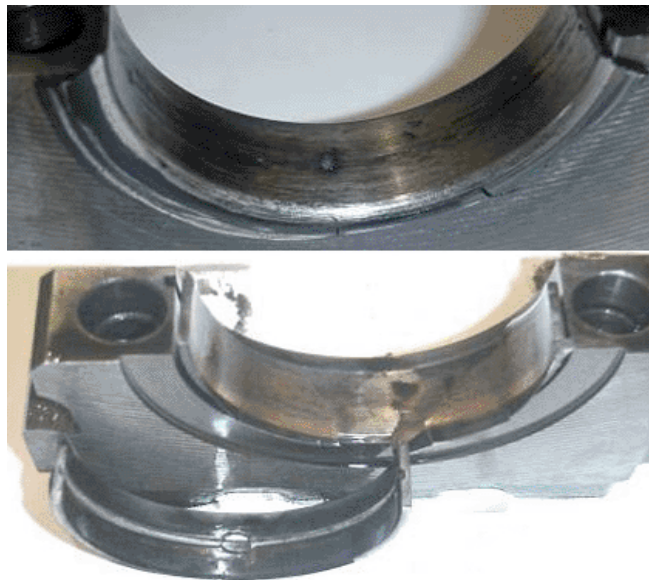
1771291

Lack of lubrication causes rapid bearing wear or bearing to seize.

Bearing failure. Spun main bearings.

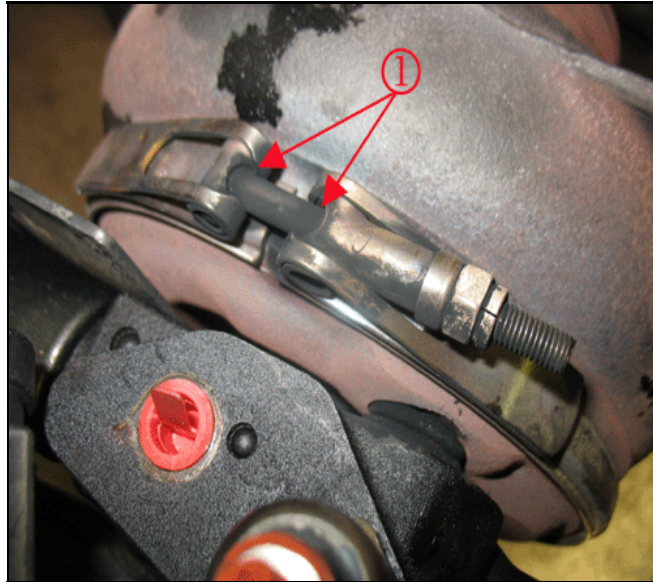
2336334

General Motors has identified a turbocharger (TC) failure mode involving Power-Up Kits that causes soot leakage and DTC P003A to be set. The Power-Up Kits create an over temperature condition from the increased exhaust gas temperatures that results in a permanent and excessive turbine housing distortion at the TC case halves.

1. A technician may observe one or more of the following conditions:
  - DTC P003A being set as Current or in History.
  - An unusual odor emanating from the TC due to an overtemperature condition.
  - Soot leaking and accumulating at the V-band clamp that secures the TC case halves together.
  - Limited or unresponsive travel when Commanding the TC Vane Pos. Ctrl. Solenoid ON and OFF with a scan tool.

2. If DTC P003A is found as Current or in History, **OR** there is evidence of soot leakage (1) in the area of the V-band clamp (1), then technicians **MUST** verify if the engine control module (ECM) has a Power-Up Kit aftermarket calibration installed or an aftermarket hardware device has been installed.

**Refer to the latest version of Corporate Bulletin Number 08-06-04-006 as well as 14-016-04-003 for the calibration verification information and procedures.**
