# Service Bulletin

Bulletin No.: 07-08-50-022C

**Subject:** Second Row Seat Rattle and/or Hard to Latch and Unlatch, Power Release Fold and Tumble Not Fully Functioning (Perform Repair as Outlined)

**Models:** 2007-2014 Cadillac Escalade Models  
2007-2014 Chevrolet Suburban, Tahoe  
2007-2014 GMC Yukon Models

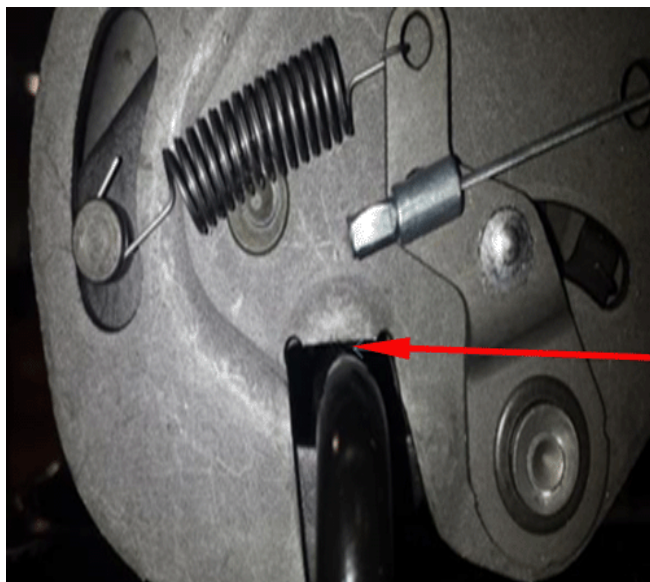
Inspect the second row seat latches for proper operation/latching. Inspect the latch to striker interface both inboard and outboard for gapping as shown. If no gapping is present, attempt to rock the seat side to side to check for any looseness at the latches to strikers. If any gapping is present, or if any looseness is observed, perform the following to seat/align the latches to the strikers.

1. With the affected seat in the tumbled forward position, “forcefully” slam the seat down into the latched position.
2. Repeat this procedure 3 to 4 times.
3. Latch the seat down using normal force and verify the rattle noise and/or latching condition is corrected.
4. If the rattle noise and/or latching condition is still present, repeat steps 1-3 one additional time.

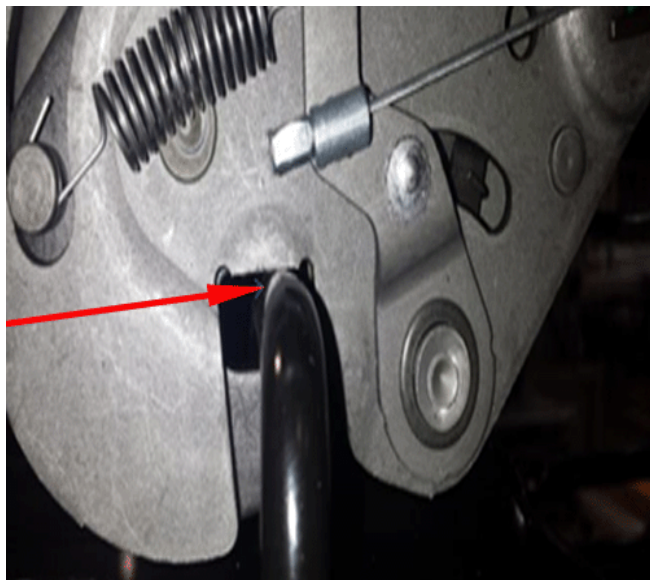
3966591

3. Slowly lower the seat to rest the latches on the strikers; **Do Not** allow the seat to latch. Observe the seat latches to mating strikers for even contact or gap.
4. If there is even contact and no gap between the latches and strikers, observe the carpet for signs of not being fully seated, or being improperly installed. Mispositioned carpet may possibly hinder full motion of the latches down onto the strikers.
5. Correct any conditions that may be caused by the carpet, then retest seat latch function.

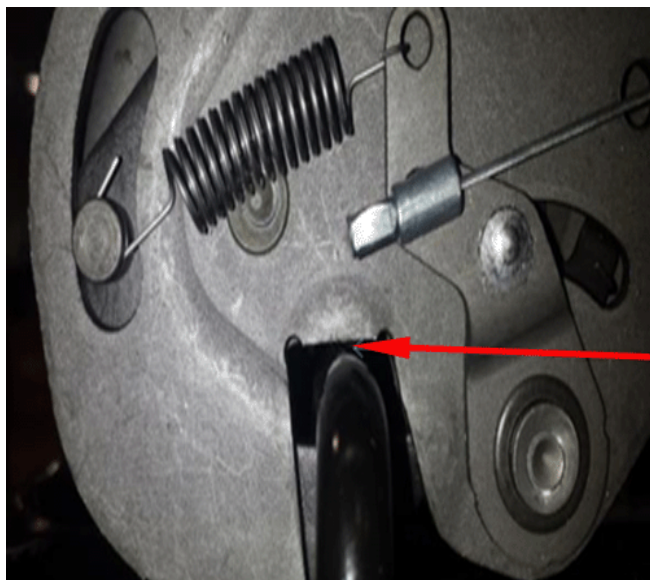
3966595

6. If a gap is present between one of the latches and the mating striker, measure the vertical gap.
