NUMBER: 23-009-14 REV. A

Gap At Rear Spoiler To Decklid

This bulletin involves inspecting and if necessary replacing the rear deck lid spoiler.

2013 JS 200

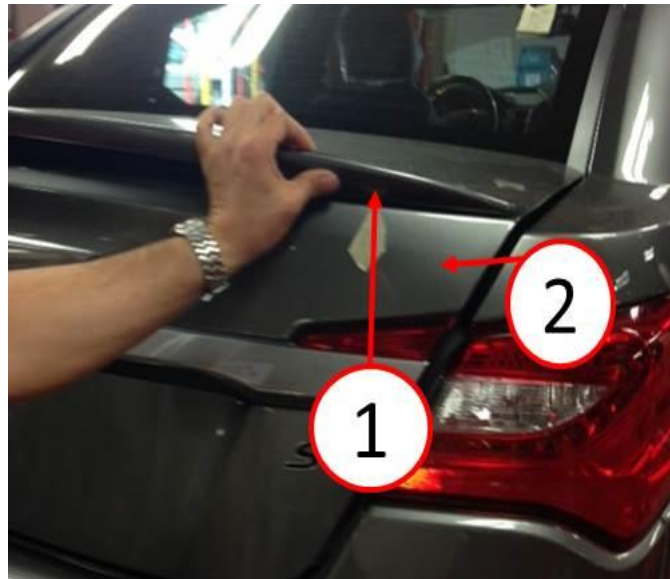
Fig. 1 Spoiler Inspection 1

1. Apply vertical upward finger load on rear most edge of spoiler at the body cross car centerline and 4" from outboard ends (Fig. 1)(Fig. 2). Inspect rear edge of spoiler for tape adhesion, was the adhesive separated and/or separating (Fig. 3)?
 - a. Yes>>> Proceed to Step 2.
 - b. No>>> Return the vehicle the customer or dealer inventory.

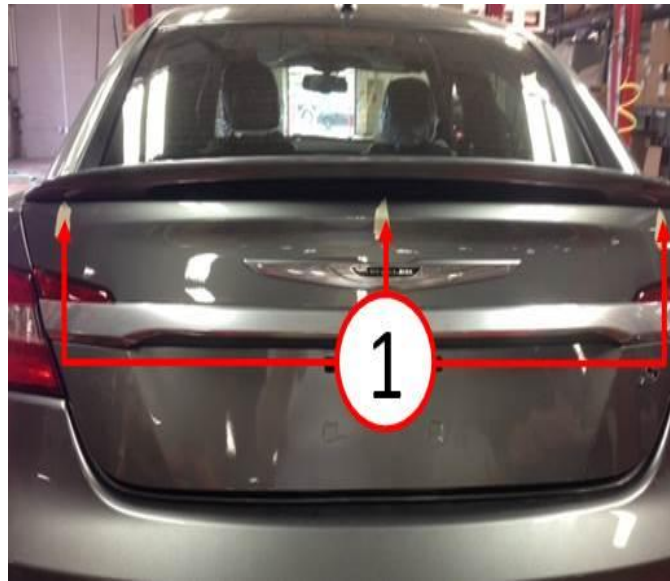
Fig. 2 Spoiler Inspection 2

1 - Areas to apply vertical upward finger load

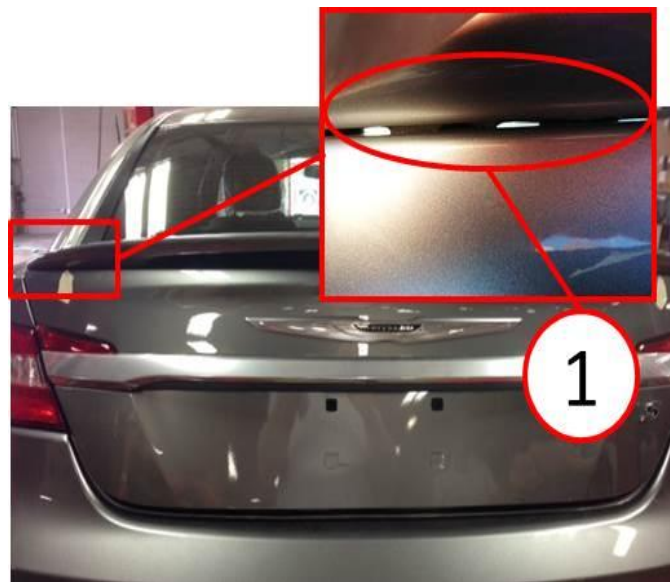
Fig. 3 Adhesion Inspection

1 - Adhesion failure

2. Remove and replace the deck lid spoiler. Refer to the detailed repair procedures available in: DealerConnect> TechCONNECT under: Service Info> 23 -Body> Exterior> Spoiler> Removal/Installation.

NOTE: Clean the surface area where the two sided tape will bond to the deck lid with isopropyl alcohol prior to installing the replacement spoiler.
