**NUMBER:** 25-002-14

**GROUP:** Emissions Control

Malfunction Indicator Lamp Illumination Due To Oxygen Sensor

2010 - 2012 (DJ) Ram Pick Up (2500)

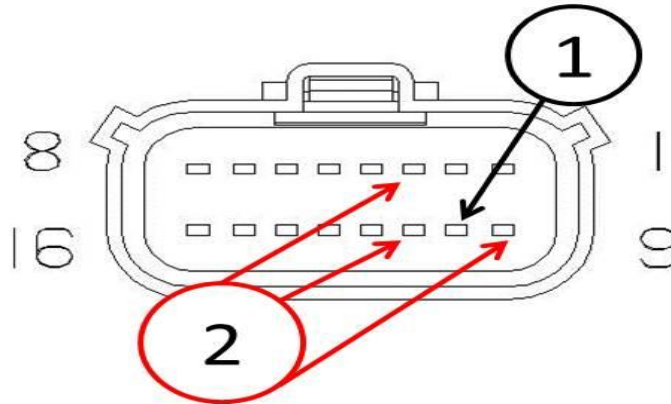
**Fig. 1 FOUR WIRES FROM TRUCK MUST BE TRANSFERED TO OVERLAY HARNESS**

1 - Terminal 10 - Always a Gold Plated Terminal

2 - Terminals 3, 9 and 11- Must be Inspected on Model Year 2011 For Gold Plating

11. Disconnect the original **Oxygen Sensor Module Connector** and remove the protective tape and plastic shield on the connector.
12. Carefully cut the tape securing the convolute tubing to the wiring near the new Oxygen Sensor Module connector and pull convolute tubing off wire bundle about 8" (203 MM) from connector.
13. The four terminals that need to be removed from the original vehicle O2 Sensor Module connector and installed in the overlay O2 Sensor Module connector are terminals 3, 9, 10 and 11 as shown in (Fig. 1). Terminal 10 will always be gold plated. Terminals 3, 9 and 11 will need to be inspected on MY 2011 vehicles for plating to determine if new terminals are required.

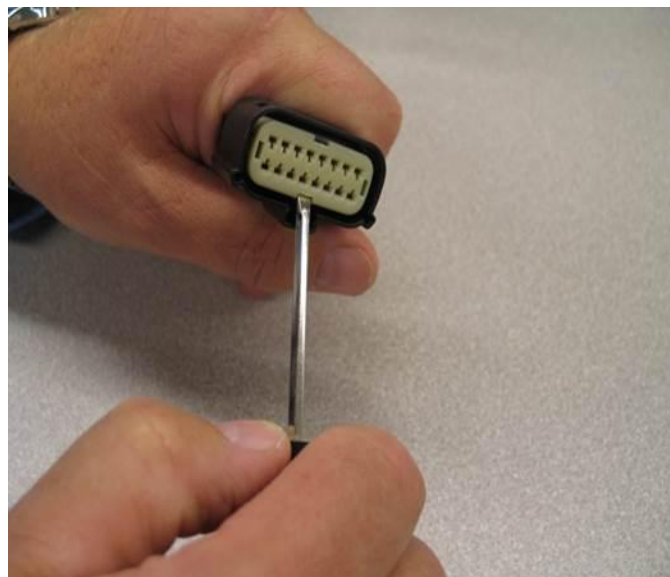
**Fig. 2 LIFT TPA 5MM**

14. To release the terminals from the original Oxygen Sensor Module connector; use a narrow blade, flat screwdriver (3 mm wide max), and pry the white TPA (white cover seen when looking in connector). Notice the travel of white TPA is only .2" (5 mm) or until a "click" is heard. This is the release point of the TPA. The TPA is a device that locks the release finger so that when seated, terminal will not and cannot be disengaged, (Fig. 2) and (Fig. 3). Do not extend the TPA past .2" (5 mm) or the TPA may be damaged.

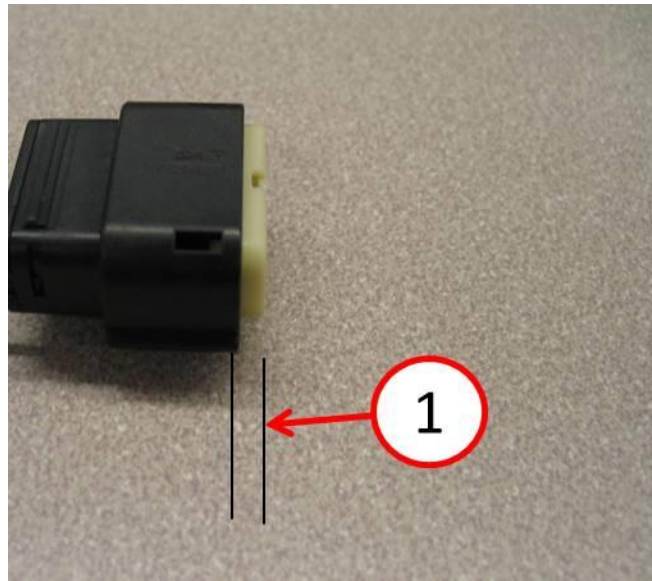
**Fig. 3 PROPER EXTENSION OF TPA**

1 - TPA Extended .2" (5MM)

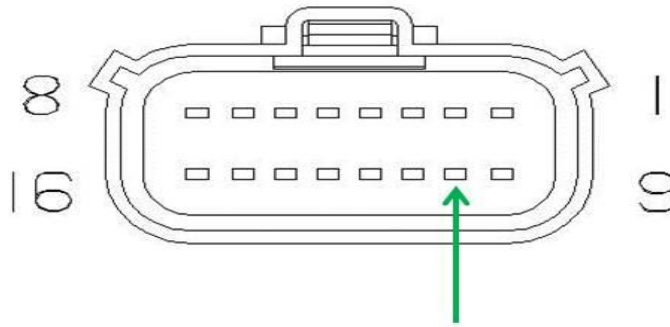
**Fig. 4 TERMINAL 10 IS A GOLD TERMINAL**

Remove Terminal 10

15. Starting with terminal #10 (Fig. 4), push the wire into the connector from the back, and while keeping the tool or drill at 90° angle to the face of the TPA, push the tool or drill in until it releases the lock finger in the connector as shown in (Fig. 5). At this point the wire should pull out the back. As the terminal is removed; note the orientation of the terminal in the connector for ease of installation later.

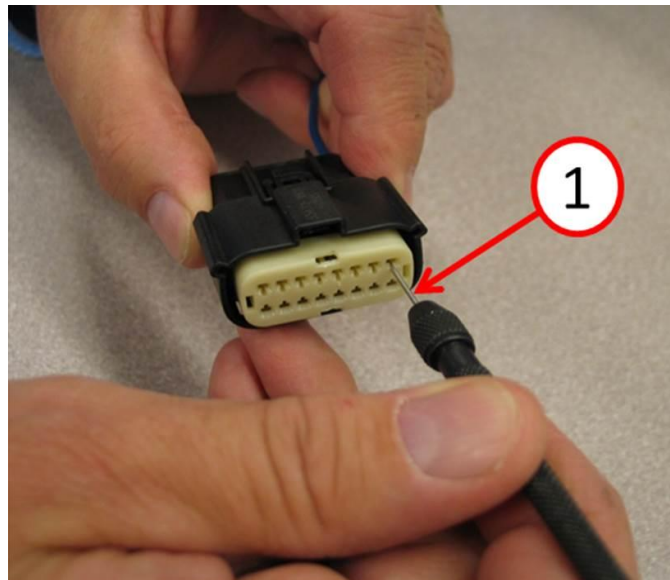
**Fig. 5 INSERT TOOL IN SERVICE PORT ADJACENT TO THE TERMINAL TO BE REPLACED**

1 - 1MM Drill Bit Used as Service Tool
