**NUMBER:** 08-067-14

Liftgate Will Not Power Close

2014 (RT) Caravan / Town & Country

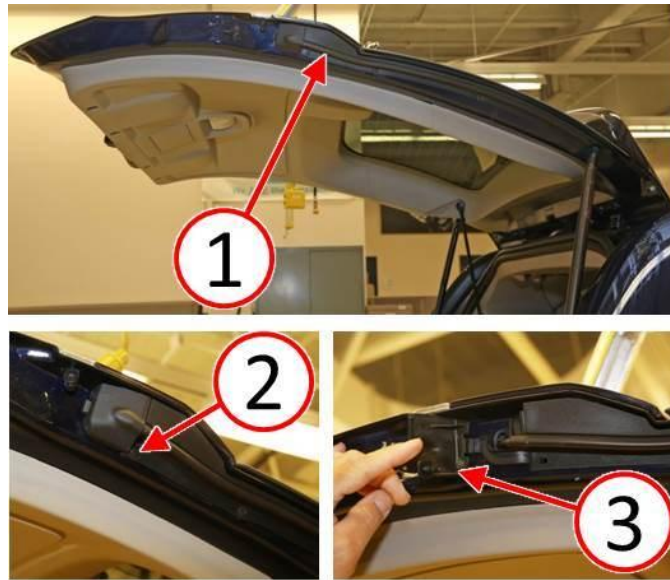
**Fig. 1 Liftgate Pinch Sensor Inspection**

1. Open the liftgate to access the right side (passenger side) lift gate pinch sensor (1) ([Fig. 1](#)).
2. Remove the push pin (2) then open the pinch sensor inspection cover (3) ([Fig. 1](#)).

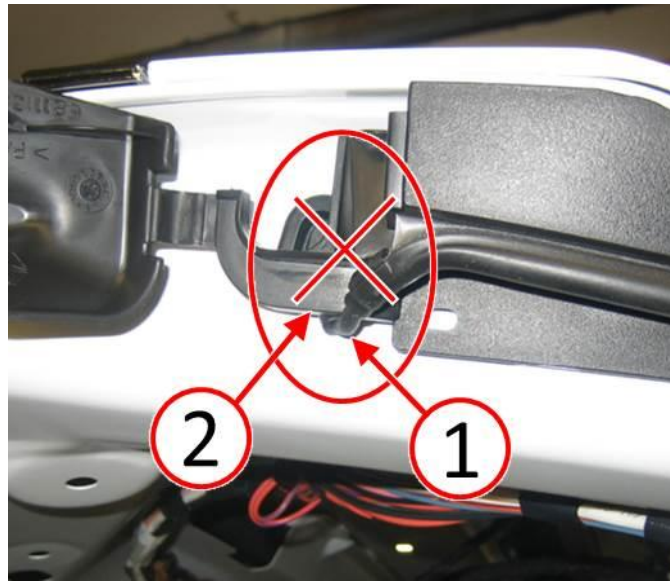
Liftgate will not power closed. Some vehicles may have an incorrectly routed right side (passenger side) pinch sensor wire harness.

- 
3. Inspect the right side pinch sensor wire harness (1) for incorrect routing under the pinch sensor (2) as shown in ([Fig. 2](#)).
    - a. Yes>>> the pinch sensor wire harness (1) is incorrectly routed under the pinch sensor (2) as shown in ([Fig. 2](#)). Proceed to [Step #4](#).
    - b. NO>>> the pinch sensor wire harness (1) is correctly routed over the pinch sensor (2) as shown in ([Fig. 3](#)). Close the pinch sensor inspection cover. This Bulletin does not apply.

***Fig. 2 Incorrectly Routed Wire Harness***

- 
4. Replace the pinch sensor (2) and route the pinch sensor wire harness correctly as shown in (Fig. 3). Refer to the detailed repair procedures available in: DealerConnect> TechCONNECT under: Service Info> 08 - Electrical> 8N - Power Systems> Power Liftgate> SENSOR, Pinch> Removal/Installation.

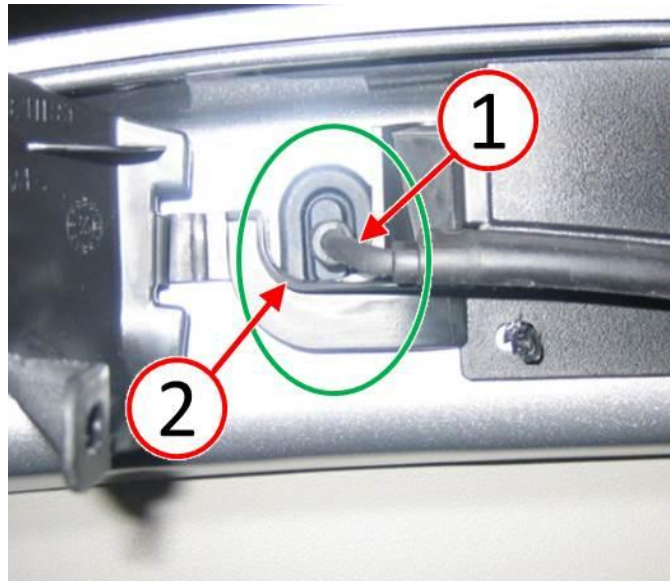
**Fig. 3 Correctly Routed Wire Harness**
