NUMBER: 08-030-14 REV. A

Flash: RE2 RE3 RE4 RE6 RE7 RB4 RB5 RB6 RB4 Radio Enhancements

This bulletin involves updating the radio's software and Navigation if required.

2013-2014	(LD)	Charger
2013-2014	(LX)	300
2013-2014	(JC)	Journey

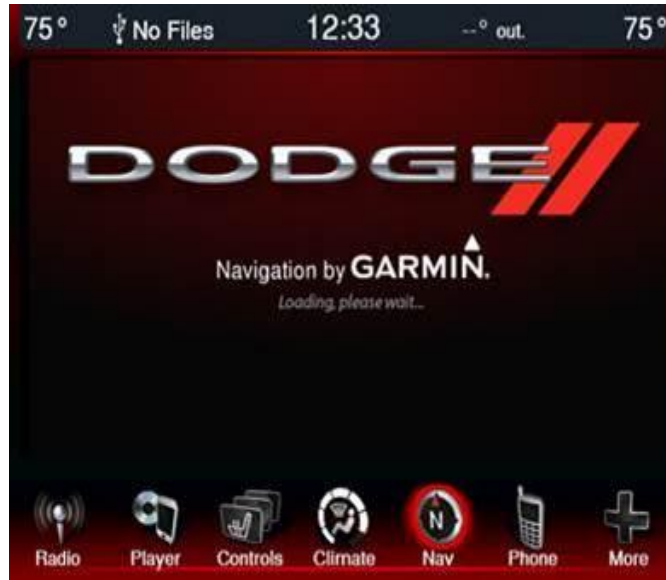
Fig. 1 System Loading Screen

1. Start the vehicle, turn the radio ON and allow it to power up.
2. If you have a RB4, RB5, RB6, RE4, or RE7 radio, press the navigation screen button and attempt to access the navigation main menu system.
3. Is the radio stuck on the “Loading Please Wait” screen? See (Fig. 1).

- a. Yes <<< The radio will have to be replaced. Replace the radio using current electronic exchange center stock following normal warranty repair procedures. Refer to published service information in Tech Connect Section 08 - Electrical/8E - Electronic Control Modules/MODULE, Telematics Gateway/Removal. No further action is required, the bulletin is now complete. The replacement radio will contain the latest software update.
- b. No <<< Proceed to [Step #4](#) and perform the software update.

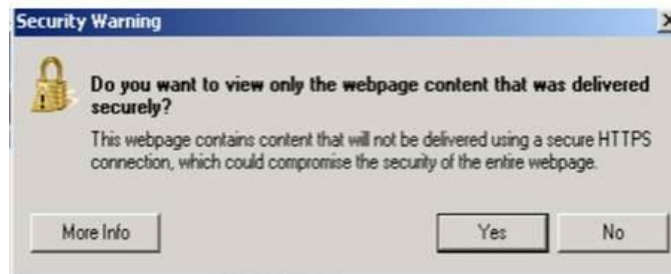
Fig. 2 Pop-up Security Message

- 4. Has a USB stick been created with the current software update?
 - a. Yes>>> Proceed to step [Step #8](#).
 - b. No>>> Proceed to step [Step #5](#).
- 5. Go to DealerCONNECT>Service>UCONNECT Information & Utilities> Uconnect Dealer software downloads to download the files.
- 6. If a security message appears "Do you want to view only the webpage content that was delivered securely?" See ([Fig. 2](#)). Press **No** to continue.

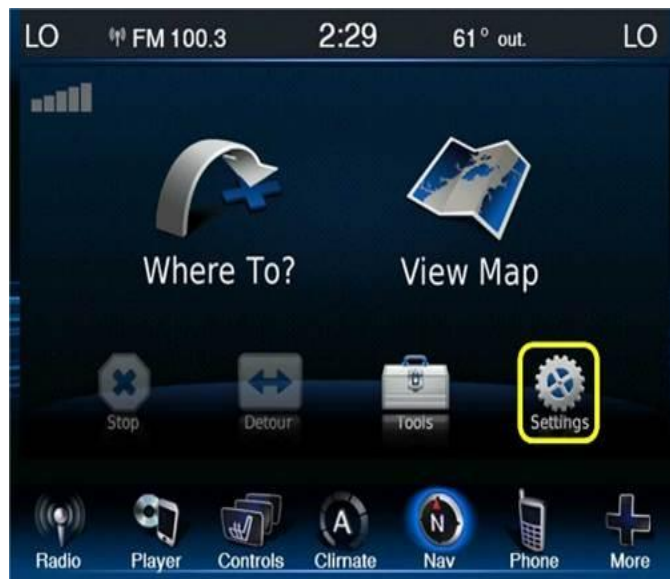
Fig. 3 Settings Icon

12. When the update is completed, the screen will read “Reflash Successful”. Touch the screen and the radio will reboot.
13. The screen will now show the current and new software levels. Verify if the new and current software levels are now the same and press no on the screen.
14. Remove the USB stick from the USB port and proceed to [Step #15](#).
15. Does this vehicle have one of the following radios, RE2, RE3, RE6 or RE7?
 - a. Yes <<< Only the radio control head needs to be updated, this bulletin is now complete.
 - b. No <<< The Garmin navigation system update needs to be performed, proceed to [Step #16](#).
16. From the navigation main menu screen, press the Settings screen button. See ([Fig. 3](#)).

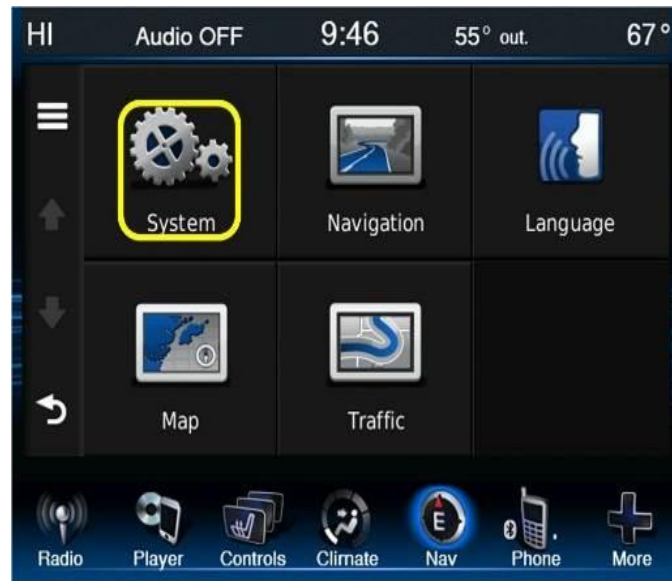
Fig. 4 System Icon

17. Press the System Icon. See ([Fig. 4](#)).

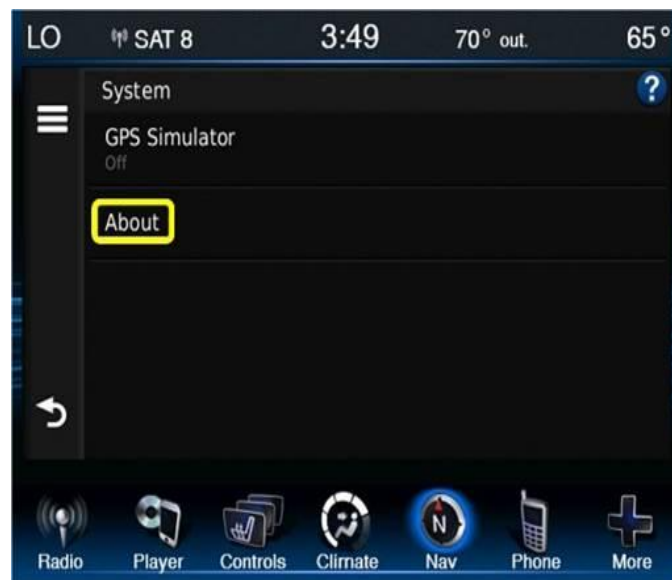
Fig. 5 About Icon

18. Press the About screen icon, See (Fig. 5), and record the software version.

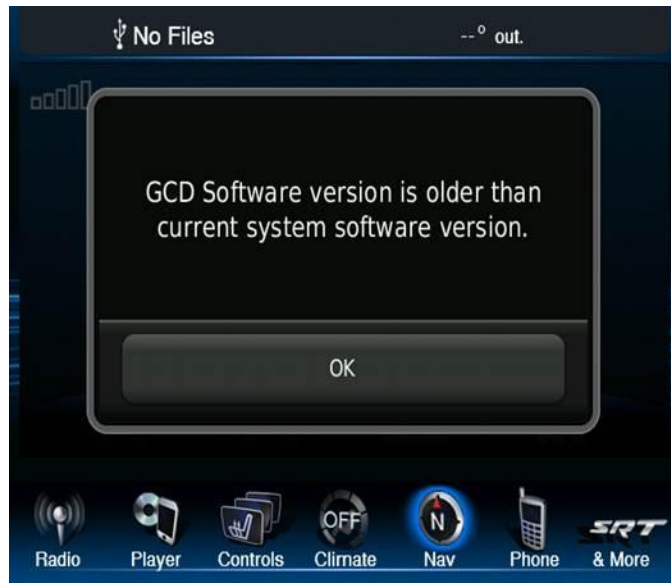
Fig. 6 Garmin Software Already Updated

19. For **2013** Model Year vehicles, is the software version 4.30 or earlier?
 - a. Yes <<< Proceed to [Step #21](#) and perform the update.
 - b. No <<< The Garmin Navigation system is already up to date. The bulletin is now complete.
20. For **2014** Model Year vehicles, is the software version 5.12 or earlier?
 - a. Yes <<< Proceed to [Step #21](#) and perform the update.
 - b. No <<< The Garmin Navigation system is already up to date. The bulletin is now complete.
21. Insert the correct USB stick containing the Garmin Navigation update into the USB port.
22. The radio screen will now display one of two pop up screen see (Fig. 6) or (Fig. 7)

23. Which screen does the radio currently display?
 - a. (Fig. 6) <<<The radio has the latest Garmin software installed. Press OK and proceed to [Step #27](#).
 - b. (Fig. 7) <<<Press Yes to continue and proceed with the Garmin software update.
24. The first step in the update is "system recover". There will be a pop up that indicates this step along with a progress bar. This will only take a few minutes.
25. This next screen will be displayed when the update is being down loaded, see (Fig. 8).

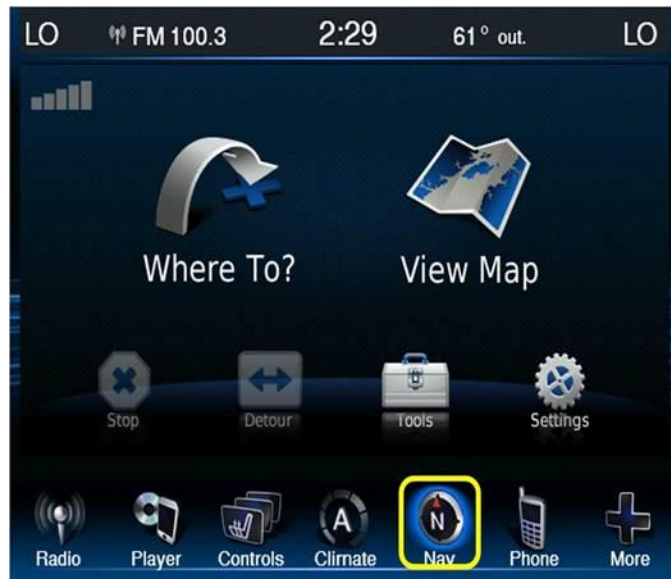
Fig. 9 Update Complete

26. When the software has completed down loading, the screen will change to the Garmin main screen, see (Fig. 9)
