NUMBER: 17-004-14

Right Rear Spring Shifted In Upper Isolator And Possible Clunk Noise

2013 - 2014 (PF)

Dart GT

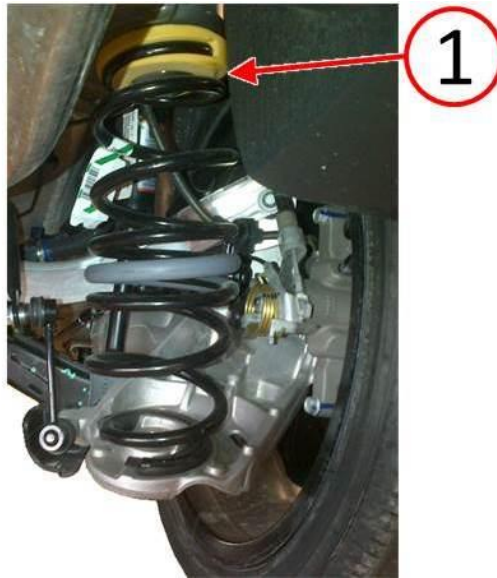
Fig. 1 Spring Seat Upper Isolator

1. Inspect the positioning of the right side rear suspension spring in the upper spring seat isolator ([Fig. 1](#)).

1 - Upper Spring Seat Isolator

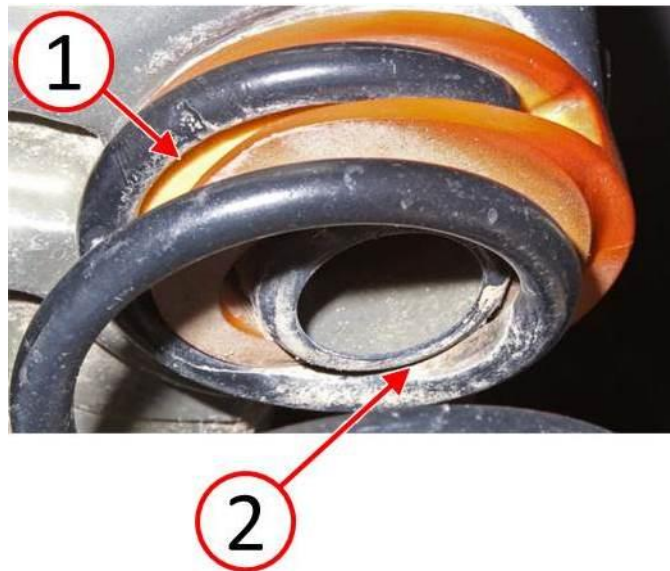
Fig. 2 Spring Shifted In Upper Isolator

Right side rear suspension spring is shifted in the upper spring mount isolator and possibly a clunk noise can be heard or felt coming from the rear of the vehicle, while going over bumps.

2. Is the right side rear spring shifted in the upper spring seat isolator (1) and/or possibly touching the upper spring seat (2) as shown in (Fig. 2)?
- Yes>>> Proceed to [Step #3](#).
 - No>>> Continue further diagnosis, this bulletin does not apply.

1 - Spring Shifted Position In Isolator

2 - Spring Touching Spring Seat

- 3. Replace both the left and right rear springs. Refer to the detailed procedures available in DealerCONNECT> TechCONNECT under: Service Info> 17 - Rear Suspension> SPRING(S)> Removal/Installation.
