**NUMBER:** 08-037-14 REV. A

**DATE:** August 29, 2014

Flash: RB4 Radio Enhancements

This bulletin involves updating the radio and navigation software, if required.

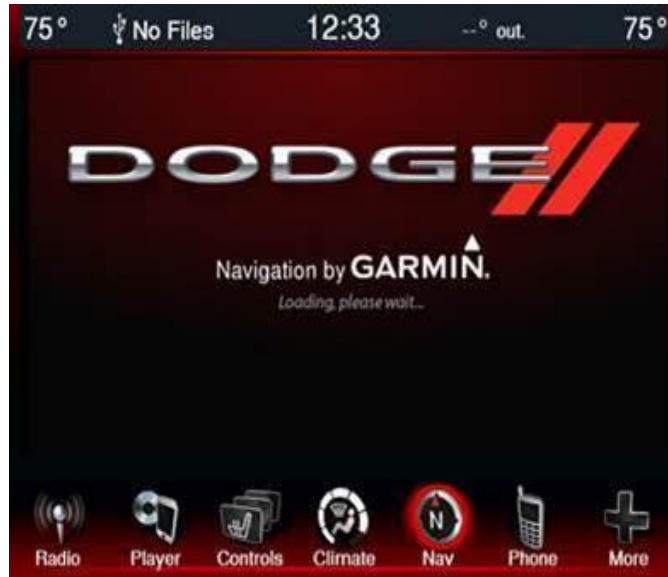
**Fig. 1 System Loading Screen**

3. Is the radio stuck on the “Loading Please Wait” screen? See (Fig. 1).
  - a. Yes <<< The radio must be replaced. Replace the radio using current electronic exchange center stock following normal warranty repair procedures. Refer to published service information in Tech Connect Section 08 - Electrical/8E - Electronic Control Modules/MODULE, Telematics Gateway/Removal. No further action is required, the new radio will have the updated software. The bulletin is now complete. Use Labor Op 18-60-02-CB to close out the RRT portion of this bulletin.
  - b. No <<< Proceed to [Step #4](#) and perform the software update.

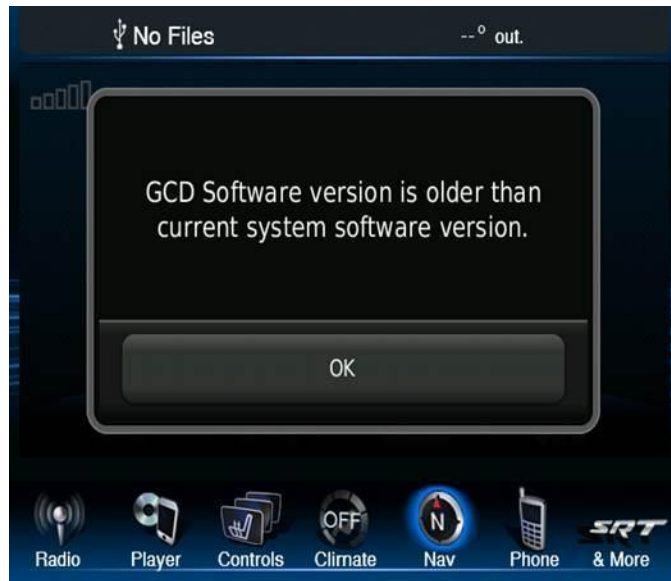
**Fig. 6 Garmin Software Already Updated**

21. Which screen does the radio currently display?
  - a. (Fig. 6) <<< The radio has the latest Garmin software installed. Press OK and proceed to [Step #25](#).
  - b. (Fig. 7) <<< Press Yes to continue and proceed with the Garmin software update.
22. The first step in the update is “system recover”. There will be a pop up that indicates this step along with a progress bar. This will only take a few minutes.
23. This next screen will be displayed when the update is being down loaded, see (Fig. 8).
