NUMBER: 18-028-14 REV. C

Flash: MIL Illumination - Diagnostic and System Improvements

2014 (DS) Ram Pickup (1500)

NOTE: This bulletin applies to vehicles equipped with a 3.0L diesel engine (sales code EXF) built on or before September 08, 2014 (MDH 0908XX).

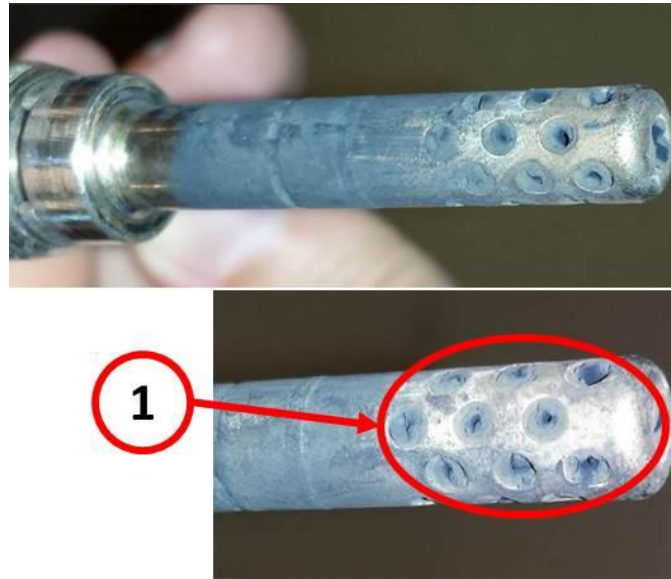
Fig. 1 EGT Sensor Bank 1 Sensor 2

10. Inspect the sensor body and probe for any signs of damage or excessive soot. Refer to (Fig. 1).

1 - Excessive soot blocking sensor ports.

-
11. Was excessive soot found on the sensor?
- Yes>>> Proceed to [Step #12](#).
 - No>>> Proceed to [Step #13](#).
12. Using shop air set to a maximum of 80 psi, clean all excessive soot from the sensor probe.
