**NUMBER:** 08-091-14

**DATE:** October 24, 2014

Exterior Lamp Condensation And Fogging

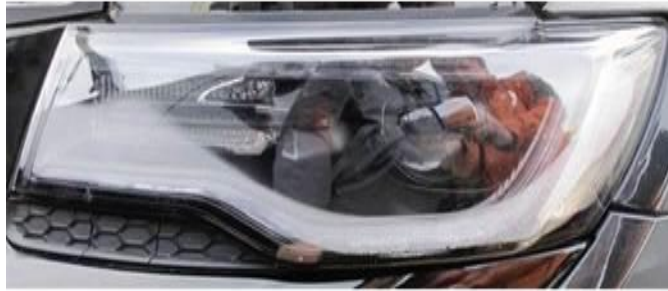
If the condensation/fogging has begun to clear from the lamp lens after 20 minutes with the lamps operating, this indicates the lamp sealing has not been breached, and the lamp does not need to be replaced ([Fig. 1](#)).

***Fig. 1 Condensation Fogging Do Not Replace***

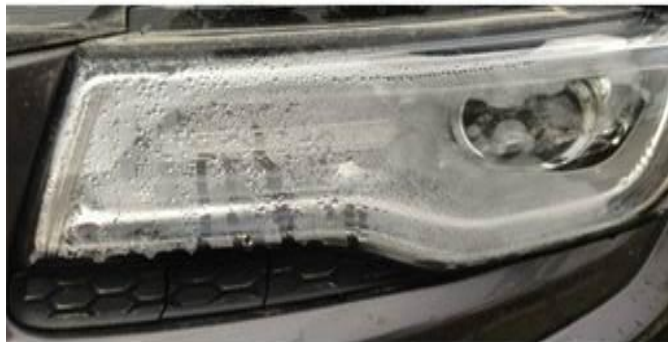
If the condensation/fogging has not begun to clear after 20 minutes with the lamps operating, or the lamp has large amounts of water droplets visible on most internal surfaces, this indicates an issue with the lamp sealing that has allowed water to enter the lamp. In this instance, the customer is also likely to report that moisture in the lamp is always present and never disappears. A lamp that exhibits internal moisture permanently should be replaced ([Fig. 2](#)).

***Fig. 2 Heavy Water Droplets Replace***
