NUMBER: 08-048-14 REV. B

Flash: Vehicle Enhancements

This bulletin involves updating the software in multiple modules, Vehicle Tracking Module (VTM), Body Control Module (BCM), On-Board Charging Module (OBCM), Power Inverter Module (PIM) and Electric Vehicle Control Unit (EVCU) if required.

2013 - 2014 (FF) 500e

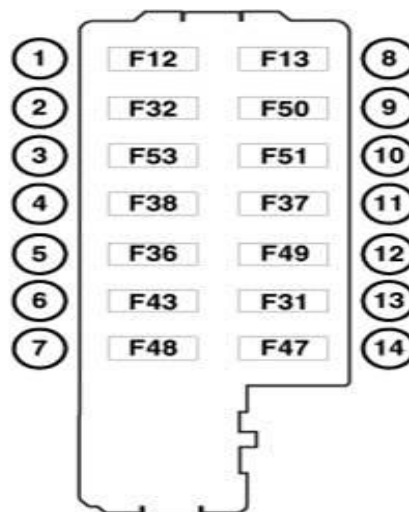
3162133

NOTE: Sometimes when updating the software on these modules, the CTM may stop communicating and/or U11F6-00 is set as an active fault. Pulling the fuse for the CTM will regain communication with that module and change U11F6-00 to a stored DTC.

Fig. 1 Interior fuse panel located by the left kick panel.

15. Is U11F6-00 set as an active fault?
 - a. Yes >>> Proceed to [Step #16](#).
 - b. No >>> Proceed to [Step #18](#).
16. Turn off the ignition and pull fuse F36 for 10 seconds. It is located in the interior fuse panel, which is part of the BCM, see ([Fig. 1](#)).

Remove fuse F36 .
