NUMBER: 08-085-14 REV. A

Hands Free Feature Inoperative

This bulletin involves updating the Convergence Telematics Module (CTM) software.

2013 - 2014 (PF) Dart

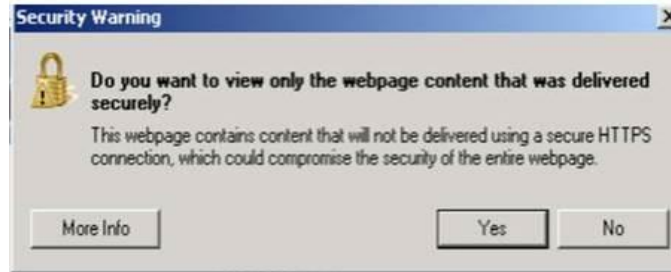
Fig. 1 Pop-up Security Message

16. If a security message appears "Do you want to view only the webpage content that was delivered securely?" See ([Fig. 1](#)). Press **No** to continue.
