NUMBER: 19-004-14 REV. A

GROUP: Steering

Excess Leather On The Steering Wheel

2014 (LX) Chrysler 300

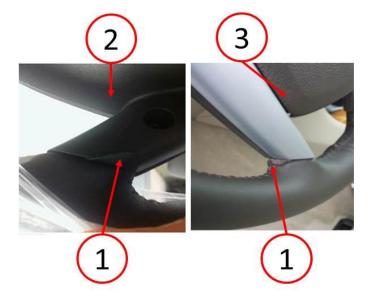
Fig. 1 Steering Wheel

Excess leather on the steering wheel.

- 1 Excess Leather
- 2 Backside of Steering Wheel
- 3 Front of Steering Wheel

- 1. Inspect the steering, is there excess leather as shown in (Fig. 1).
 - a. Yes>>> Remove and replace the steering wheel, Refer to the detailed service procedures available in DealerCONNECT> TechCONNECT under: Service Info> 19
 Steering> Column> Wheel, Steering> Removal/Installation.
 - b. No>>> Return the vehicle to the customer.
