Service Bulletin

Bulletin No.: PI0998C

Subject: Accessory Tri-Fold Tonneau Cover Prevents Endgate/Tailgate from Closing

Models: 2014 Chevrolet Silverado 1500
2015 Chevrolet Colorado, Silverado
2014 GMC Sierra 1500
2015 GMC Canyon, Sierra

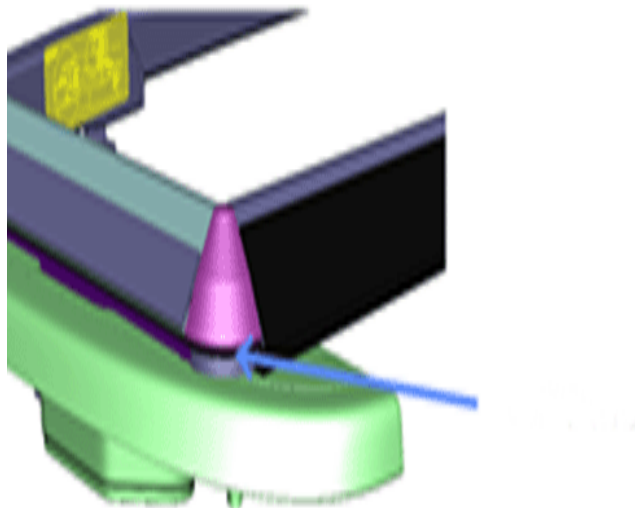
3461386

Some customers may comment that the tailgate will not close with the tri-fold tonneau cover in the closed position. This may be due to an early production condition caused by excessive twist in the rear rail of the tonneau cover, and the tailgate molding is not positioned flat on top of the tailgate.

2. Remove the adhesive liner from the pad and attach to the rear current corner pads on the right and left side as shown in the illustration above.

Note: If additional clearance is required, add a second layer of corner pads to each side.
