# Service Bulletin

Bulletin No.: P11097A

**Subject:** Intermittent Service Power Steering Message on DIC, DTC C0544 Set

**Models:** 2013-2014 Cadillac ATS

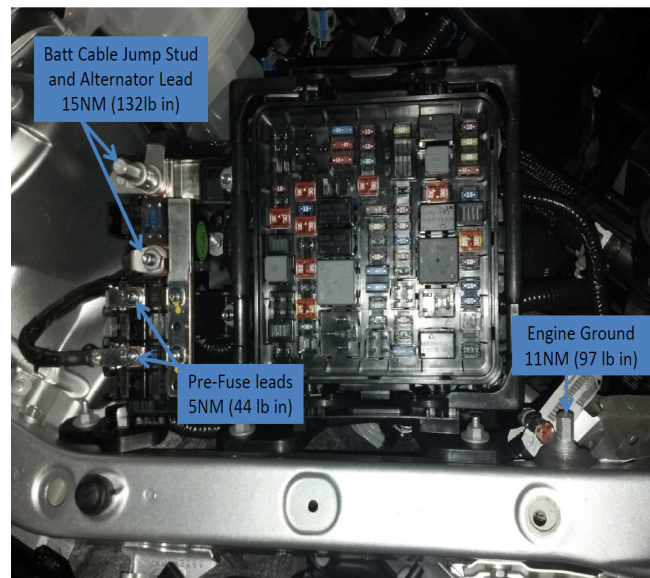
3648055

If no DTCs are present, the issue may be caused by a momentary loss of power or ground in the power steering gear circuits. Use the following steps to correct the condition.

1. Inspect the underhood fuse block power and ground connections for proper torque as identified in the above photo.
2. Inspect the X1, X2 and X3 connectors at the Power Steering Control Module (steering gear) for damaged or spread terminals on the vehicle harness or on the Power Steering Control Module. Ensure the connectors are completely seated.

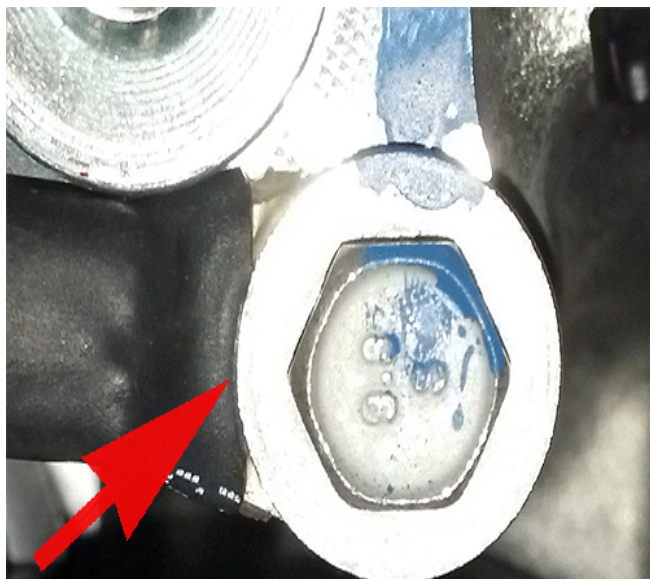
3575838

Look for either excess shrink wrap or glue under the eyelet. Inspect for adhesive that has seeped out onto the eyelet during the heating of the shrink tube, or the shrink tube itself extending into the eyelet area.

**Important:** It is not an adequate check to simply try to wiggle the ground wire to check for looseness. The ground must be removed and checked for these items, cleaned and reinstalled.

- Carefully trim the heat shrink tube if needed, clean adhesive from the eyelet (sand off), reinstall and torque.
