NUMBER: 23-016-14

Rattle Noise From The Right Rear Sliding Door While Driving Over Bumps

2013 - 2014 RT

Town And Country / Caravan

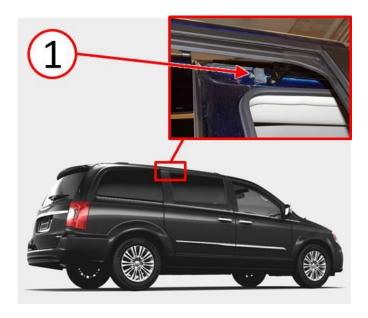
Fig. 1 Remove Bumper

1 - Rubber Bumper

- Test drive the vehicle over bumps to verify that the rattle noise is coming from the right rear sliding door.
- 2. Pause the test drive stopping the vehicle at a safe location such as a parking lot.
- 3. Open the right rear sliding door and remove the rubber bumper (Fig. 1) from the rear end of the upper door track, then close the door.

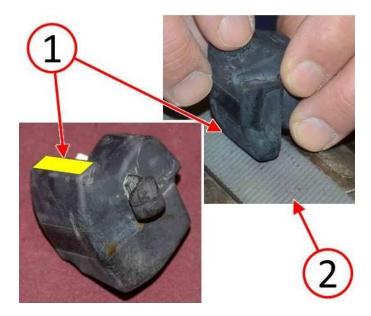
Fig. 2 Modify Bumper

- 1 Rubber Bumper Surface
- 2 Coarse File
- 6. Install the modified rubber bumper to the vehicle.
- NOTE: In the following step, ensure the paper is not positioned or trapped between the door and a door seal which will result in a false inaccurate tension resistance test.
- 7. Hold a piece of paper (1) in front of the rubber bumper (2). Make sure fingers and hands are clear of the door opening then shut the door while holding the paper in position (Fig. 3).

- 4. Continue test driving the vehicle over the same road conditions to determine if removal of the rubber bumper eliminated the rattle noise.
 - a. YES the rattle noise was eliminated. >>> Continue to Step #5.
 - b. NO the rattle noise was NOT eliminated. >>> Reinstall the rubber bumper. This Bulletin does not apply. Further diagnosis is required.
- 5. Using a coarse file (2), remove 1 mm of material from the rubber bumper surface (1) indicated in (Fig. 2).

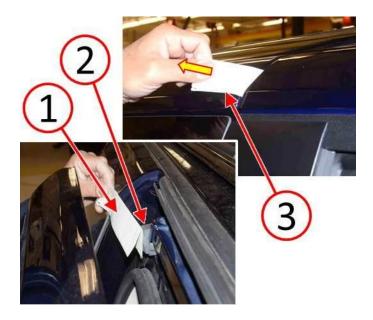
Fig. 3 Check Bumper Clearance

NOTE: There is an intended design clearance of approximately 1.8 mm between the rubber bumper and the sliding door inner panel.

- 1 Position Paper
- 2 Rubber Bumper
- 3 Tension/Resistance Test

- 8. Slowly pull the paper (3) while feeling for any tension or resistance on the paper during paper removal (Fig. 3). If tension or resistance was felt while removing the slip of paper, that would indicate a contact interference condition between the rubber bumper and the door inner panel.
 - a. YES, tension or resistance was felt. >>> Repeat the rubber bumper material removal Step #5 and retest clearance with the slip of paper until no tension or resistance is felt.
 - b. NO, tension or resistance was NOT felt. >>> Continue to Step #9.
