**NUMBER:** 23-018-14

Armrest Storage Compartment Lid Difficult To Latch

This bulletin involves replacing the front center seat armrest storage compartment lid bumpers.

2013-2014	DS	1500 Pickup
2013-2014	DJ	2500 Pickup
2013-2014	DP	4500/5500 Cab Chassis

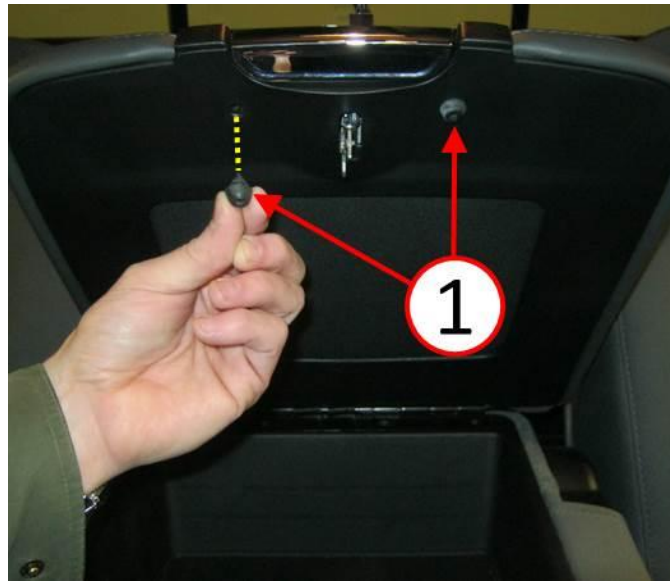
**Fig. 1 Armrest Lid Bumper Replacement**

Front center seat armrest storage compartment lid is difficult to latch due to hard lid bumpers.

1 - Armrest Lid Bumpers

1. Replace both front center seat armrest storage compartment lid bumpers ([Fig. 1](#)).

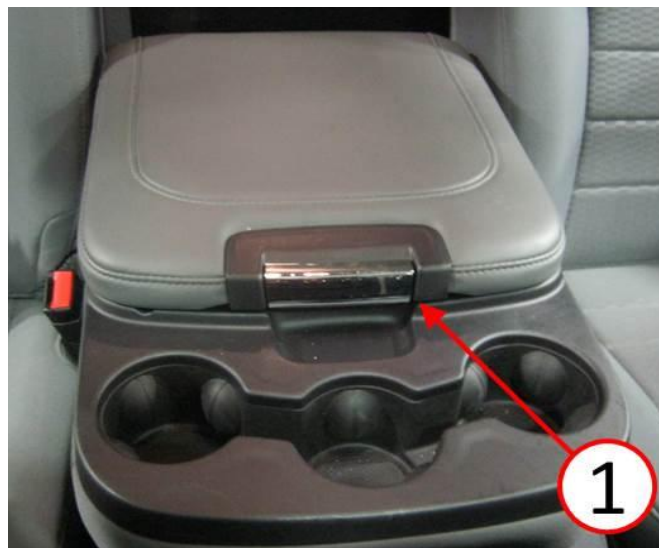
**Fig. 2 Armrest Lid**

1 - Armrest Lid

2. Verify that the front center seat armrest storage compartment lid latches properly (Fig. 2).
