122SD and Coronado
> Business Class M2
Cascadia
> 108SD/114SD

**Freightliner
Service Bulletin**

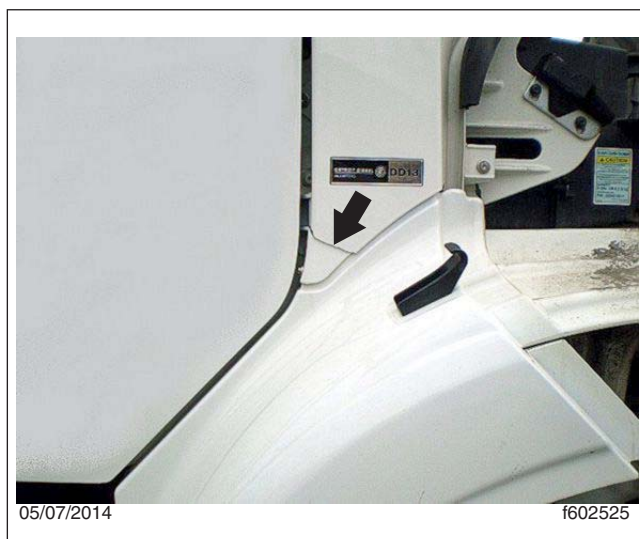
On some M2 and 108SD/114SD vehicles built before February 17, 2014, the side cowl panel can crack near the lower corner (see [Fig. 1](#)). Removing the screw that attaches the lower corner of the cowl panel to the quarter fender improves the durability of the cowl panel. Testing has proven that this attachment point is not structurally necessary, and the screw is no longer installed in production. Use the procedure below to remove the screw on each side of the vehicle.

Fig. 1, Cowl Panel Cracking

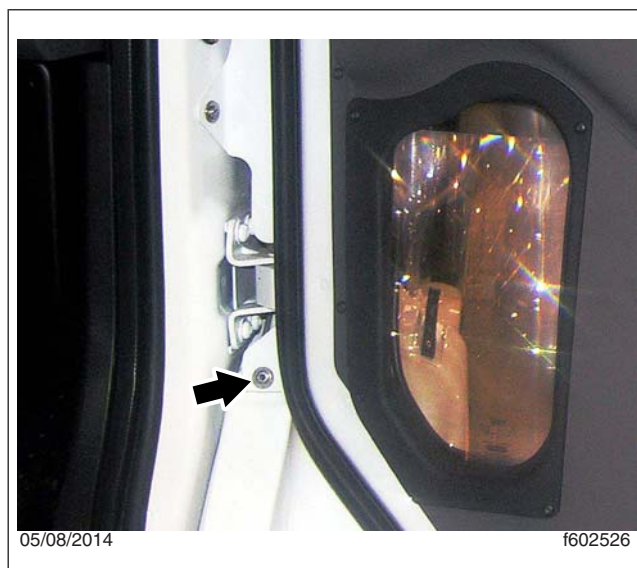
Fig. 2, Cowl Panel Lower Corner Screw

NOTE: When replacing a cowl panel, omit the lower corner screw.

1. Park the vehicle on a level surface, shut down the engine, and set the parking brake. Chock the tires.
2. Open the cab door.
3. Remove the screw that attaches the lower corner of the cowl panel to the quarter fender. See [Fig. 2](#).
