**No.: 14 TS- 16**  
May 9, 2014

SUBJECT: **Excessive Overhead Engine Noise on DD Platform Engines**

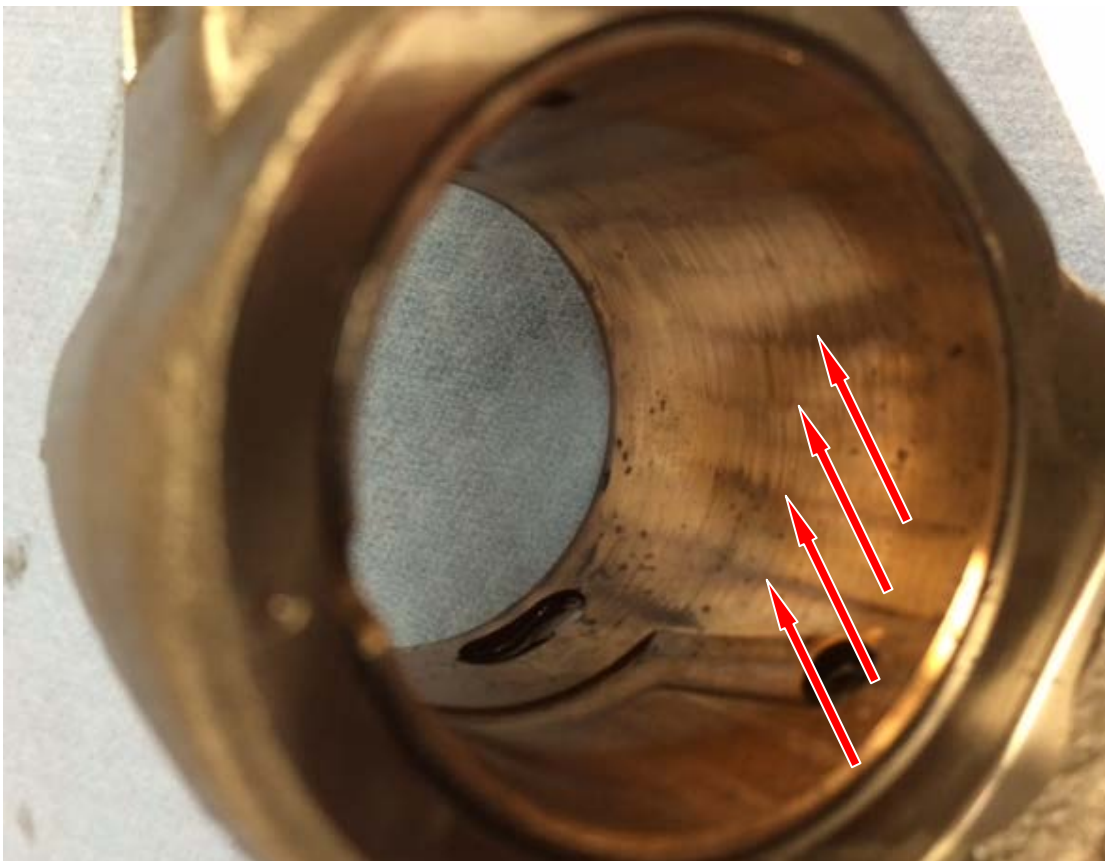
There have been cases of excessive overhead engine noise complaints on low mileage GHG14 engines caused by lobed rocker shafts. The rocker shaft damages the bushing in the rocker arm, which develops a ticking or rattling noise. The figure below displays the chatter marks.

If a unit arrives at a repair facility with an excessive overhead noise complaint, consult Power Service Literature Engine Manual section, "Removal of the Rocker Shaft Assembly." Visually inspect the bushings for chatter marks. If the bushing has similar damage as seen above, the rocker shaft is the primary failed part and must be replaced along with the rocker arm.
