## MIL is on with P0420 or P0430

### SYMPTOM

MIL is on with DTC P0420 and/or DTC P0430 (catalyst system efficiency below threshold) with a possible DTC P2243 and/or DTC P2247 (A/F sensor 1 circuit high voltage).

One or both A/F Sensor 1 (Air Fuel Ratio) caps may have fallen off and bored a hole through the affected WU-TWC (Warm Up Three Way Catalyst).

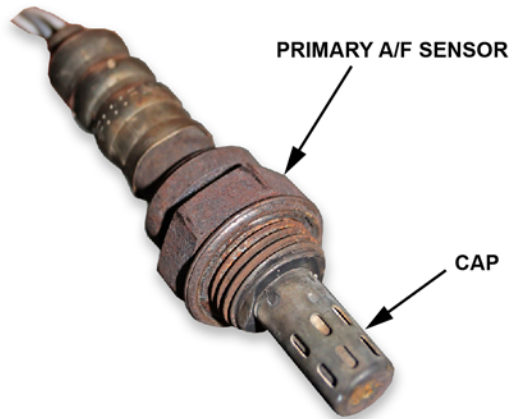
**GOOD**

3. Check for a missing cap from the primary A/F sensor.
