**MIL Is On With DTC P0420 or P0430****SYMPTOM**

The MIL is on with DTC P0420 or DTC P0430 (catalyst system efficiency below threshold) with a possible DTC P2243 or DTC P2247 (A/F sensor 1 circuit high voltage).

**VEHICLES AFFECTED****2010 MDX:**

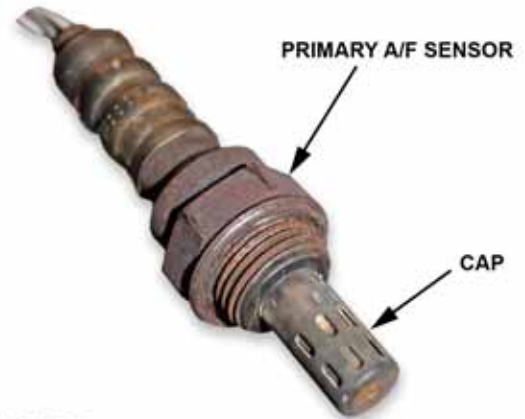
**GOOD**

2. Remove the primary A/F sensor located on top of the affected catalytic converter. For example: If DTC P0420 is stored remove the rear (bank one) primary A/F sensor.
3. Check for a missing cap from the primary A/F sensor.

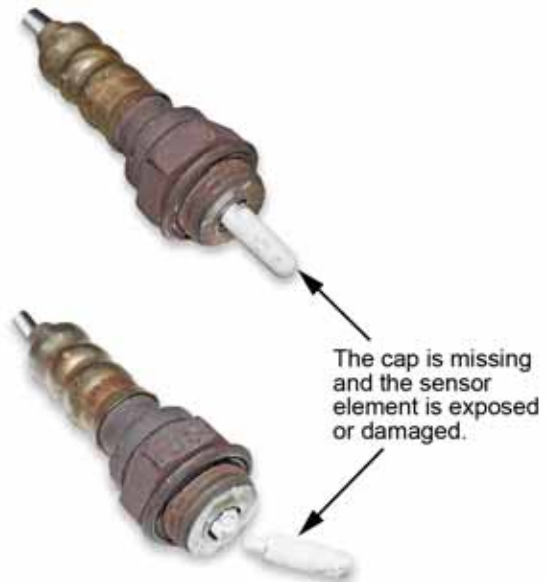
**NO GOOD**

One or both primary A/F Sensor (Air Fuel Ratio) caps may have fallen off and bored a hole through the affected WU-TWC (Warm Up Three Way Catalyst).

- If DTC P0430 is stored and the cap is missing from the front (bank two) primary A/F sensor, go to REPAIR PROCEDURE A
- If DTC P0420 is stored and the cap is missing from the rear (bank one) primary A/F sensor go, to REPAIR PROCEDURE B.
- If the cap is not missing, this bulletin does not apply. Continue with normal troubleshooting.
