## Service Bulletin

Issue Date: March 28<sup>th</sup>, 2014

Subject: **Helper Leaf Spring**

Models Affected: **Chevrolet Models having a Wheelchair Lift**

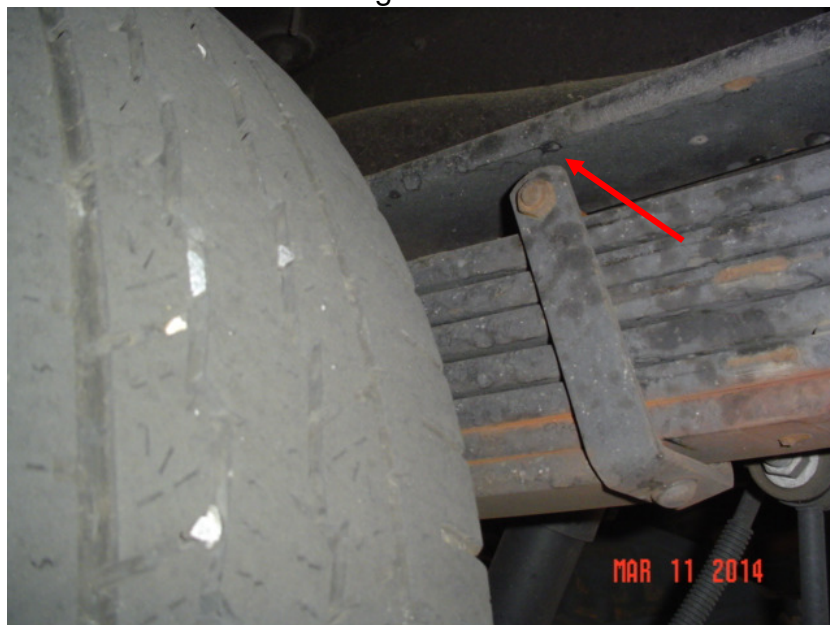
Issue: Helper Leaf Spring is wider than the OEM Shackle and if fully compressed will rub OEM shackle.

NOTE: There are two OEM shackles on the leaf spring.

Location: Passenger side rear, above axle. See Figure 1-A
