This Service Information bulletin supersedes SI B61 22 13 **dated November 2013**.

**"Increased battery discharge!" CC Message upon Startup**

F01, F02 (7 Series Sedan)

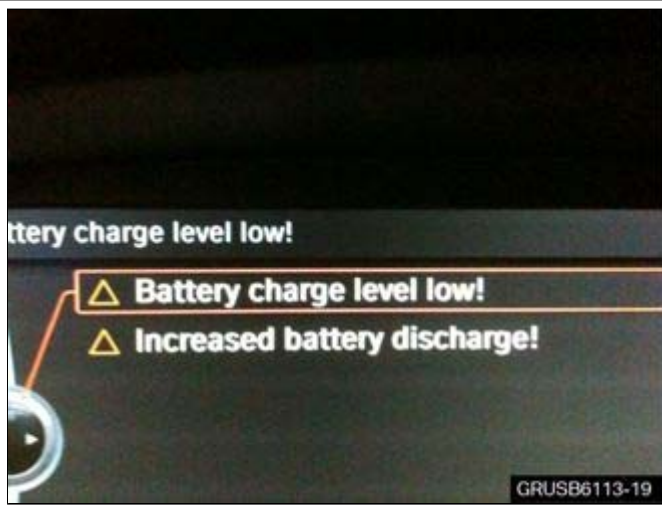
<p>The screenshot shows a dark background with two yellow warning icons (triangles) and text. The top message reads "Battery charge level low!" and the bottom message reads "Increased battery discharge!". A small text box in the bottom right corner of the screenshot contains the code "GRUSB6113-19".</p>	<p>The Check Control message "Increased battery discharge!" is displayed in the Central Information Display (CID) when the vehicle is started. In some cases, the CC message "Battery charge level low!" is also displayed. The message occurs sporadically. In most cases, a fault code is not set for the Intelligent Battery Sensor (IBS).</p>
---	---

A software error in the Intelligent Battery Sensor causes an incorrect State of Charge (SoC) to be stored in the DME. The power management system then interprets this as a heavily discharged battery and informs the customer via a CC message. In reality, the battery does not have a problem.

1. Diagnose the vehicle using ISTA 3.39 (introduced in September 2013) or later, and complete the "Energy diagnosis" test plan.

2. If “IBS faulty” is listed in the results of the energy diagnosis test module screen, follow the test module recommendation, and replace the IBS sensor with the improved part listed below under “Parts Information.” Refer to ISTA Repair Instruction 6112...“General information on intelligent battery sensor (IBS).”
3. If “IBS faulty” is **not** listed in the results of the energy diagnosis test module screen, diagnose all other most likely causes as listed in the test module until the energy diagnosis test plan is completed. Refer to [SI B61 13 05](#) for information about the energy diagnosis test plan. Refer to [SI B61 02 11](#) for information about advanced onboard battery diagnostics.
