### Active Headlight Control Malfunction in Both Headlights

F30 (3 Series)

Produced from June 30, 2011 to February 27, 2014

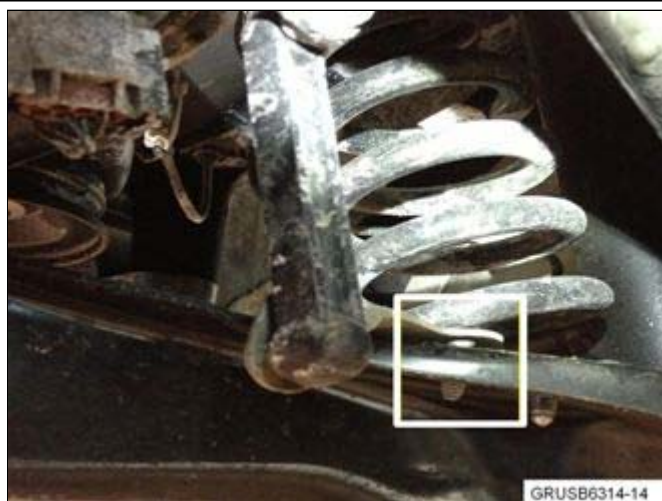
Broken mounting bolt holding on the rear height sensor bracket

- Inspect the rear height sensor, located in the right rear of the vehicle as shown.
- If the hex bolt is broken, remove the broken bolt. (Unscrew the broken bolt out or, if necessary, drill it out.)
- Replace with a new bolt and nut. Tightening torque is 8 Nm.
