This Service Information bulletin supersedes SI B64 06 13 **dated January 2014.**

A/C Cooling: Intermittent Reduction of Air Flow

F30 (3 Series Sedan)

Produced from July 4, 2012 to September 2, 2013

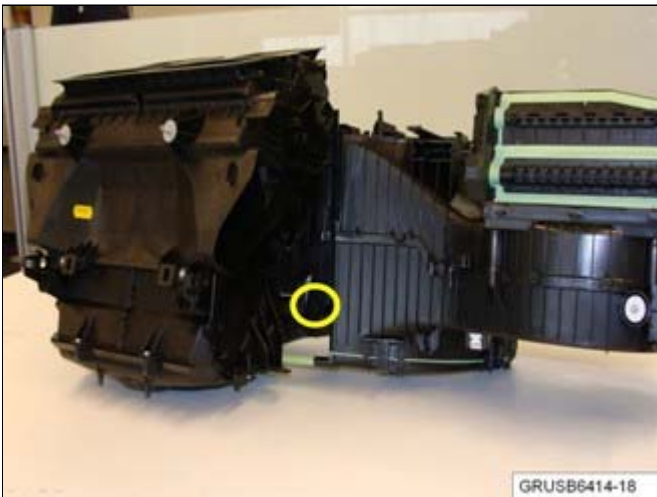
4. The IHKA housing (removed for clarity) shown is viewed from the passenger's side. The circle shows the approximate location of the evaporator temperature sensor.

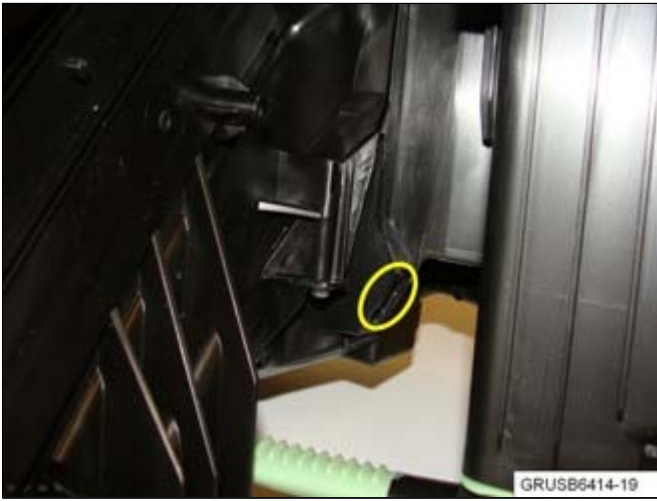
5. The close-up picture shows the exact location (circle) of the sensor opening. The following steps will be performed from the lower passenger's footwell area at the bottom of the IHKA housing.

Note: As a reference point, the evaporator temperature sensor is located just above the white ribbed rubber water drain hose, when viewed from below.

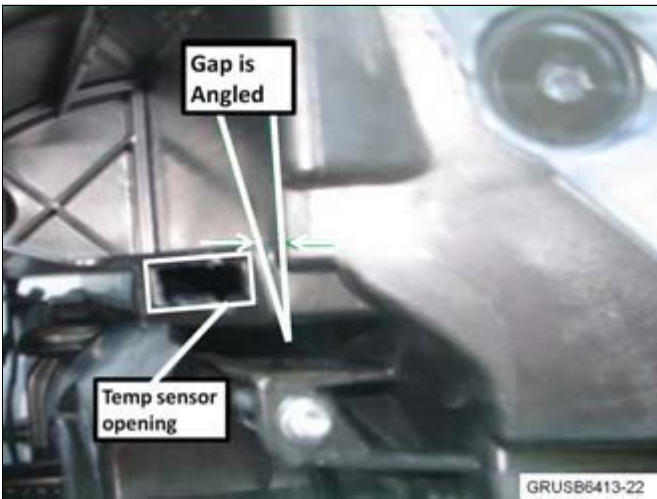
Evaporator starts to freeze up due to the position of the evaporator temperature sensor

6. Locate the evaporator temperature sensor opening (sensor removed for clarity). Check the gap between the sensor opening and the evaporator case. If the sensor opening contact surface is slightly angled as shown, this housing is **NOT** affected by this repair procedure. In this case, proceed with normal A/C diagnostic procedures.

If no gap exists proceed to the next step.

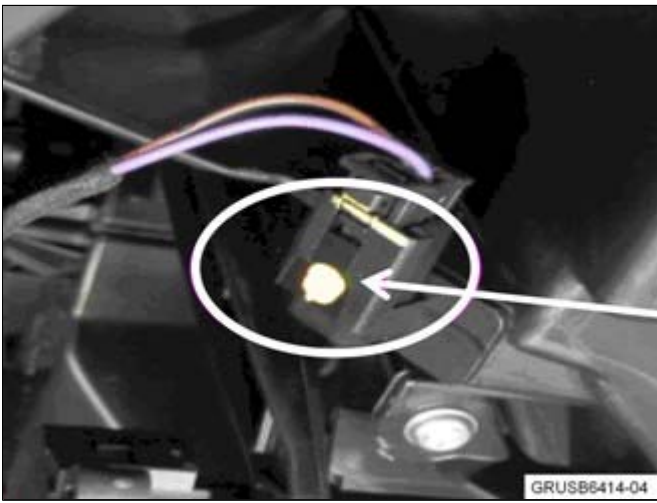
7. Check for a marking on the electrical connector. If a mark is seen or **NO** gap exists, the IHKA housing must be modified.

Do not replace any parts. The repair procedure includes installing a new adapter to correct the gap.

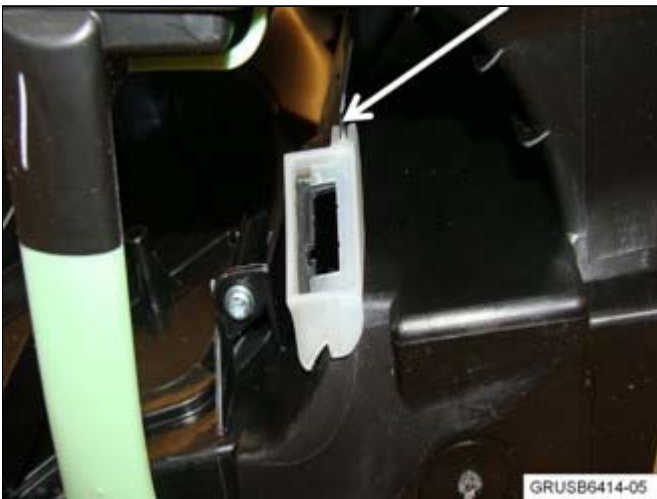
Note: The arrow shows the slot in the adapter that is properly fitted into the raised rib of the housing.

8. Insert the new adapter firmly into the sensor opening, as shown.
