SUBJECT

Squeaking Noises when Steering Wheel Is Turned

F30

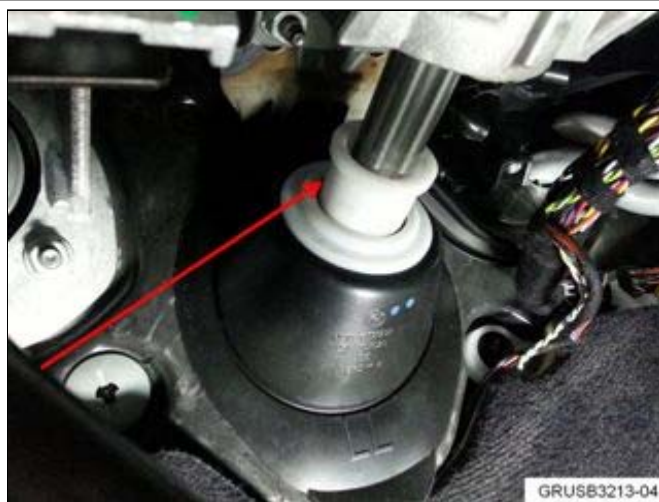
There are squeaking noises from the steering spindle when the steering wheel is turned.

The steering spindle gaiter is insufficiently lubricated.

Lubricate the plastic bearing of the steering spindle gaiter from the vehicle interior and also the portion coming out from the engine compartment.

Remove and install the trim panel for pedal assembly; refer to Repair Instruction 51 45 184.

Lubricate the plastic bearing of the steering spindle gaiter with lubricant (P/N 83 23 2 327 735).

Only lubricate the plastic ring of the sleeve and the steering spindle. Then spread the anti-friction agent by moving the steering wheel left and right, and lubricate again.

Repeat this procedure 3 times.

NEW NOTE: The use of other lubricants/greases may lead to increased squeaking.
