**Outside Door Mirror Triangle Seal Protrudes and Creates Wind Noise**

F15

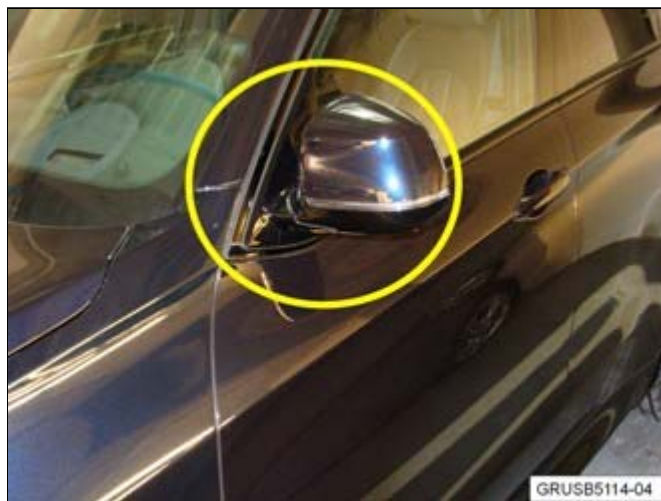
The customer may complain of wind noise and/or poor fitment of the door mirror seal.

The outside mirror seal locking tab shows poor fitment.

1. Locate the affected mirror or mirrors. Either side mirror or both may be affected. Refer to Repair Instruction 51 16 001, "Removing and installing/replacing mirror on left or right front door" and remove the affected outside door mirror. The ISTA repair instructions are included below.

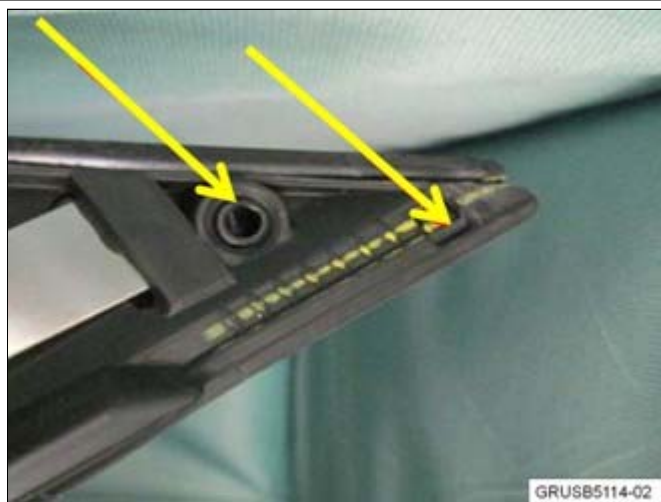
11. **Note: The driver's side mirror is shown.** Locate the two areas securing the triangle seal to the mirror housing. Pay special attention to the fitment around the circular boss and the locking tab of the seal to the mirror triangle housing. Refit the seal properly, and reinstall the mirror.
