SI B51 05 14  
Body Equipment

**Service Action: Remove Water Drain Plugs from E-Box**

F30

Produced from October 2011 to January 2014

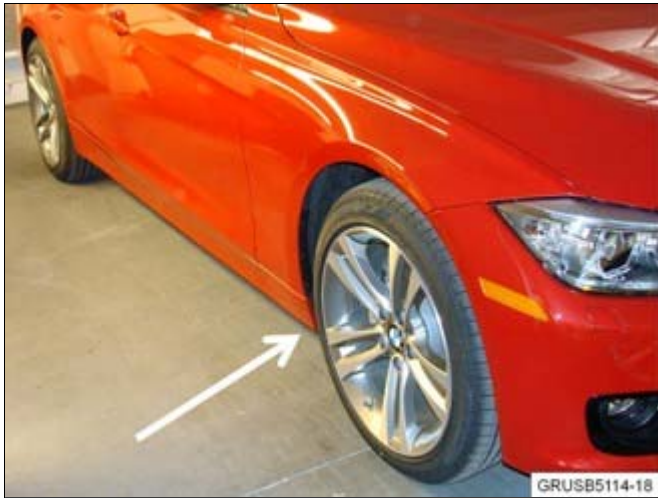
The following repair procedure shows the right side; the same procedure applies for the left.

1. Raise the vehicle with the service lift to access the lower wheel house trim fasteners.

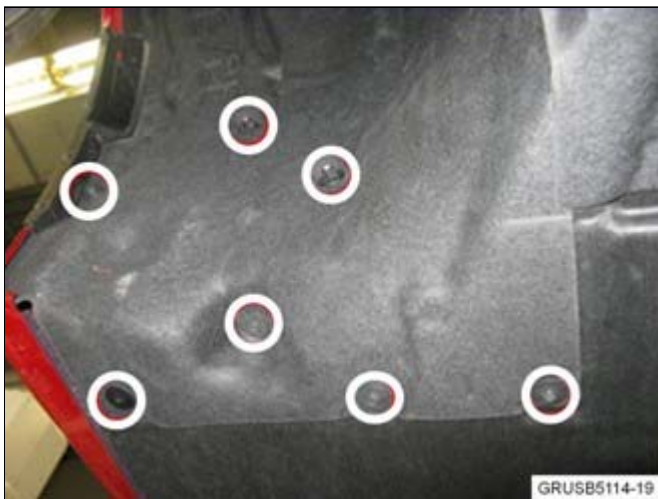
Note: The picture is of the front passenger's side wheel house trim, at the rear side.

2. Remove the seven fasteners as shown.

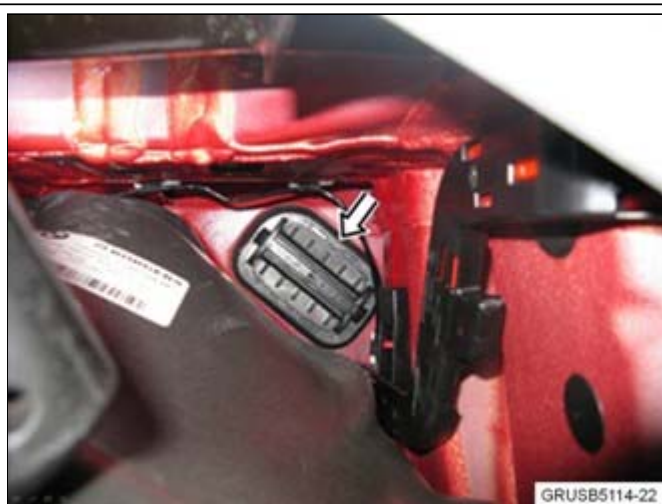
The water drain plugs for the left- and right-side E-box may clog. This can lead to water collection/corrosion and allow water to enter the passenger compartment.

The water drain plug slots are too small.

5. Remove the water drain plug in the direction of the arrow and pull downward. With the drain plug removed, reach inside the E-box body opening and remove any remaining leaves, dirt or debris.
