SI B51 22 13
Body Equipment

Child Safety Switch Lever in Rear Door Is Not Visible

F15

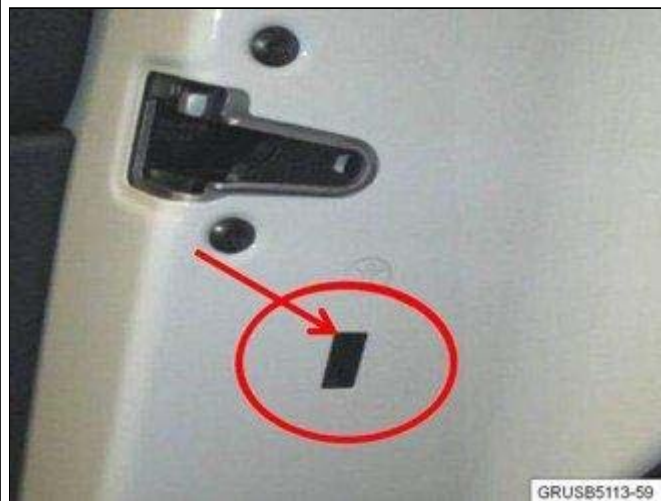
Improper door latching mechanism installation (safety lock lever is hidden behind the sheet metal)

1. This picture of the rear door latch shows that no locking lever is visible to operate the child safety lock.
2. Remove the affected door trim panel using ISTA Repair Instruction 51 42 000, "Remove and install left or right rear door panel trim."
