ELV Does Not Release

E90, E91, E92, E93 (3 Series) to 9/2006 (with Manual Trans) and to 12/2006 (with Auto Trans)

E60, E61 (5 Series) to 3/2007

E63, E64 (6 Series) to 3/2007

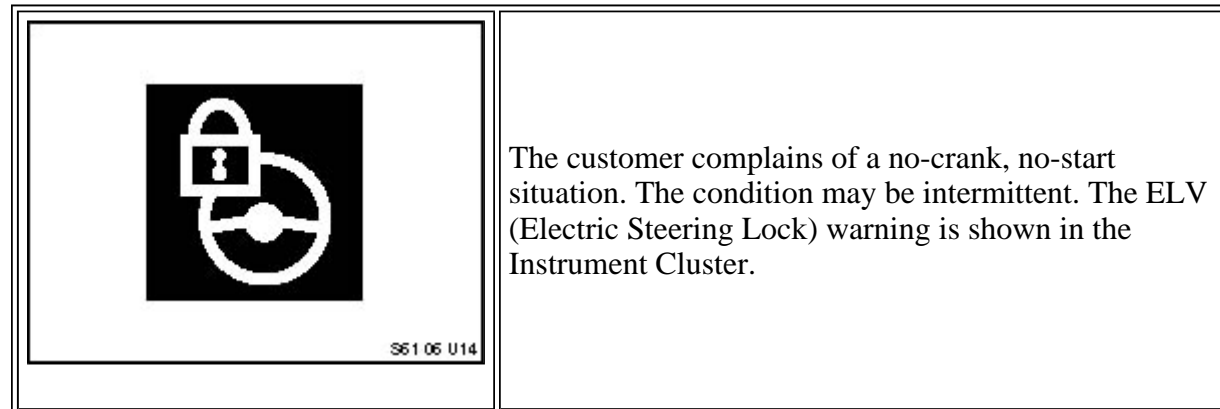
Cause 1: The steering column is held against the steering lock because of torque from the steering gear. In such cases, a yellow check control warning (CC ID# 187) is shown in the instrument cluster, but no faults are stored.

Cause 2: Communication fault in the CAS (Car Access System) and ELV system network and/or battery low. The problem may cause the ELV warning to be displayed in yellow or red.

Cause 1: Relieve the torque from the steering wheel and repeat the starting operation. No repairs are necessary (refer to the Owner's Manual for more information).

Cause 2: In the case of a customer complaint, before connecting to the BMW Diagnosis System, duplicate the "no-crank" complaint.

For comfort access-equipped vehicles, rule out specific comfort access-related issues by inserting the remote key in the key holder.

NEW Carry out a short test – do not delete the fault memory. Follow the relevant ISTA test plans,

NEW If KL-15 cannot be switched on, start diagnostics by selecting the vehicle manually. Then follow the diagnostics path: Activities / Function structure / Drive / Engine start / Comfort start / Start search to get to the test plan “Start function.”
