SI B64 06 13  
Body Equipment

**A/C Cooling: Intermittent Reduction of Air Flow**

F30

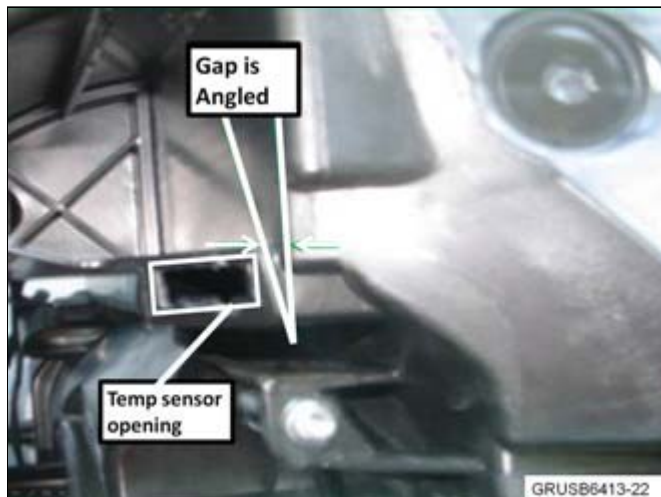
2. With the footwell panel removed, locate the evaporator temperature sensor opening (sensor removed for clarity). Note the gap between the sensor opening and the evaporator case. If the sensor opening contact surface is slightly angled as shown, this housing is **NOT** affected by this repair procedure. In this

| | <p>case, proceed with normal A/C diagnostic procedures.</p> |

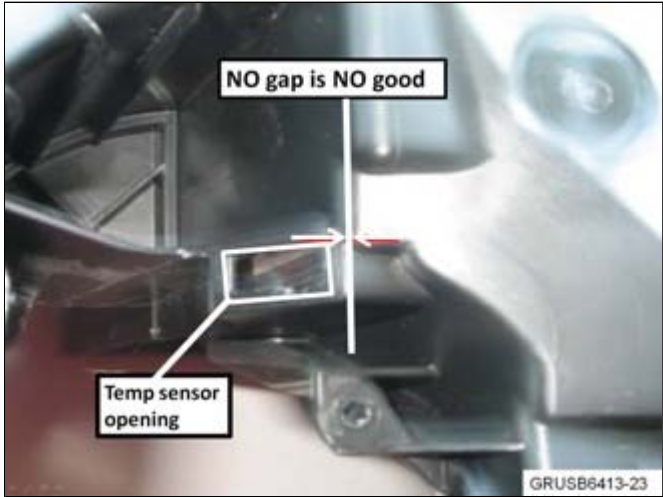
| | <p>3. If no gap exists and the sensor opening contact surface is not angled as shown, the IHKA housing must be modified. <b>Do not replace any parts. The repair procedure includes installing a new adapter to correct the gap of the sensor as shown in the next steps.</b></p> |

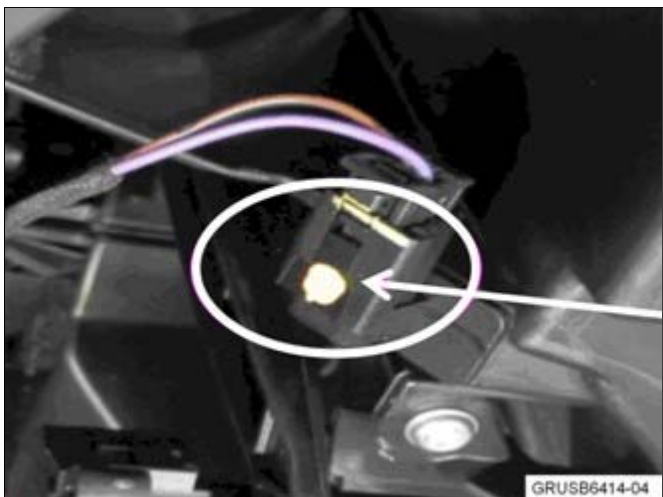
| | <p>4. Also, if a yellow-colored marking exists on the sensor connection, the new adapter must be installed. Refer to Repair Instruction 64 11 943 and remove the evaporator temperature sensor.</p> |
