SI B64 09 13
Heating and Air Conditioning

Service Action: Program IHKA Control Unit

E89

Produced from March 2013 to July 2013

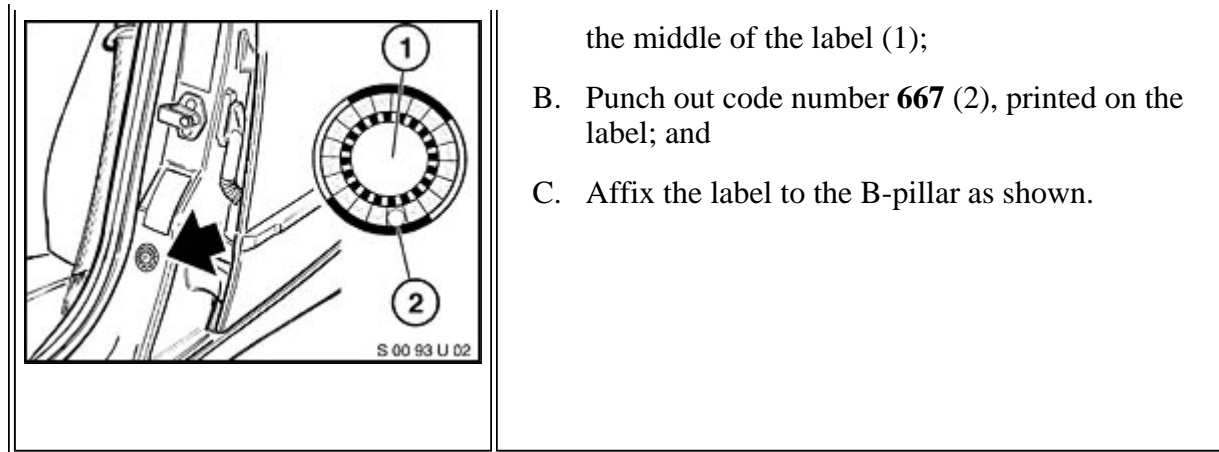
the middle of the label (1);

- B. Punch out code number **667** (2), printed on the label; and
- C. Affix the label to the B-pillar as shown.

If the vehicle already has a label from a previous Service Action, affix the new label next to the old one. Do not affix one label on top of another one because a number from an underlying label could appear in the punched-out hole of the new label.
