**SUBJECT****Rubbing Noise from Front Axle****MODEL**

F01, F02 with xDrive (7 Series Sedan)

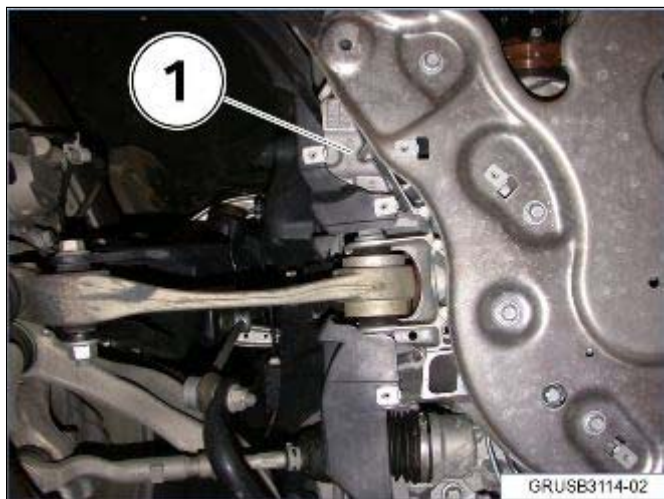
Verify the noise is coming from the driver's side front axle. Secure and raise the vehicle to remove both front and rear engine underbody protection panels. Inspect the vibration absorber (refer to Repair Instruction RA 51 47 490 and 491 to remove the panels).

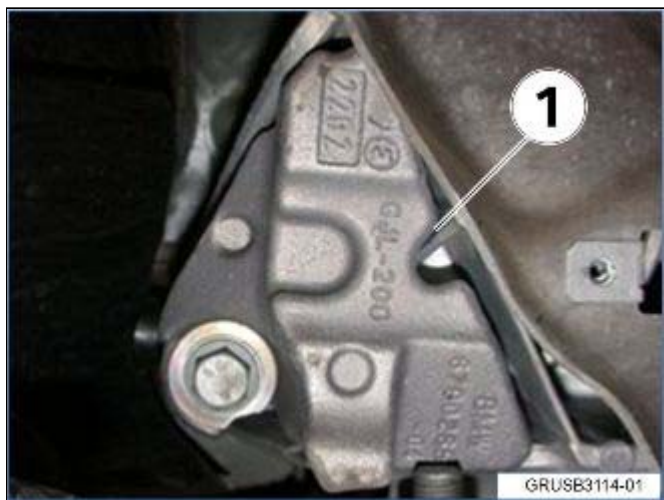
Inspect the position of the vibration absorber, which is located on the left side of the axle support (1).

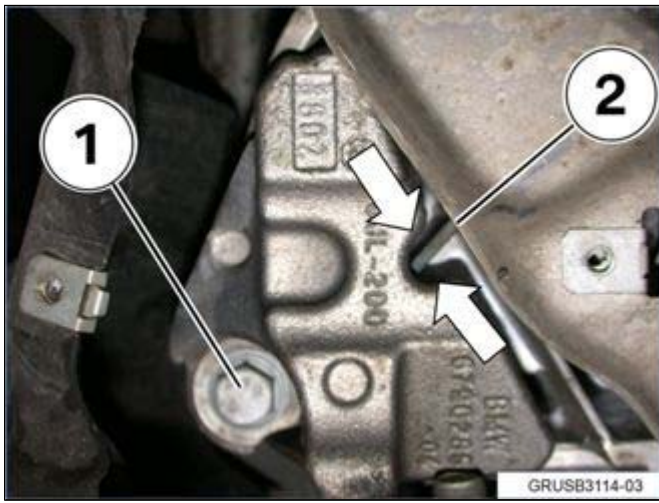
The vibration absorber **should not** make contact with the bracing of the axle support (1). If the vibration absorber is already in the correct position (see figure below), further diagnosis will be needed to find the cause of the noise.

Loosen the M12x1.5x145 bolt (1) in the axle support enough to rotate the vibration absorber. Position the vibration absorber so there is an equal gap around the bracing on the axle support (2). Torque the axle support bolt to 100Nm after adjusting the vibration absorber.
