**SUBJECT****Noise from Rearview Mirror****MODEL**

F30 (3 Series Sedan)

Produced from July 1, 2011

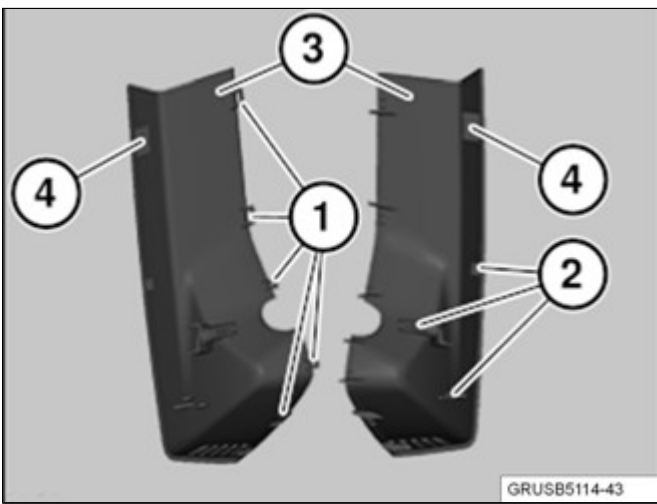
## 2. Installation note:

The latch mechanisms (1) and guides (2) on both end caps (3) must not be damaged.

For the end caps (3) with tabs (4), the spacers must be bonded onto the tabs (4).

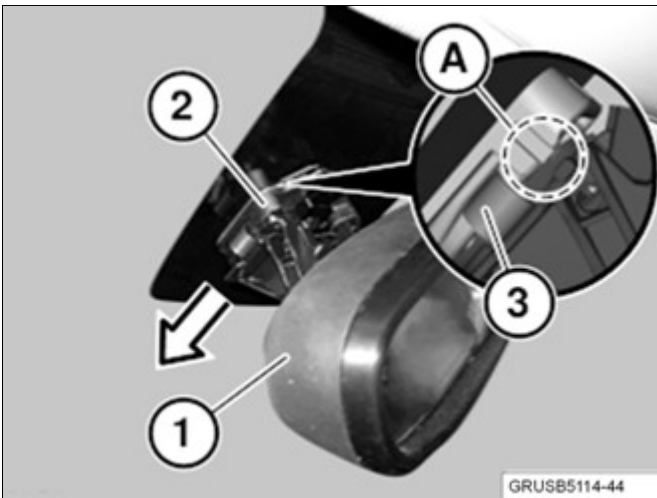
## 3. Important!

When removing the mirror base, never turn or disengage towards the front or rear.

The mirror is held to the mirror socket (2) by the clamp (3) and the latching mechanism in area (A).

It is not necessary to disconnect the electrical plug connection on the mirror (1).

The retaining clips (3) must not be bent or damaged.

The inside mirror (1) in area (A) must be correctly engaged to the mirror socket (2).

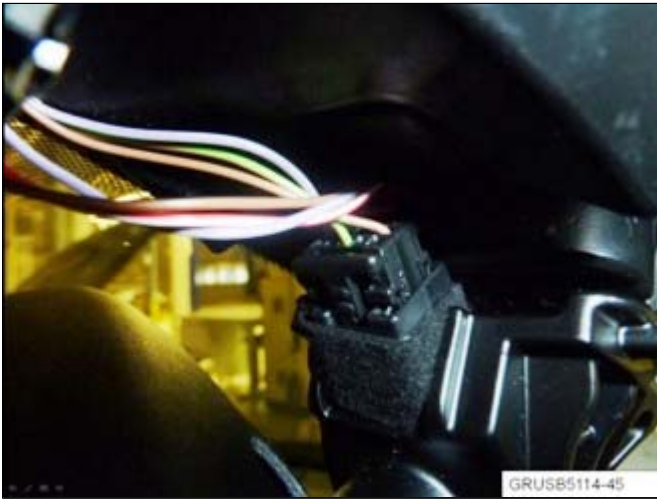
## 4. Remove the electrical connector from the mirror base holder.

The mirror electrical connector is loose in the mirror base.

**Note:** This close-up shows the electrical connector already

wrapped with the felt and  
reinstalled into the holder.

Prepare a felt strip (50mm x 15mm x 1 mm) and wrap the felt tape around the connector. Reinstall the connector into the holder as shown.
