### Taillight Is Loose in the Trunk Lid

**NEW** F30 (3 Series Sedan)

**NEW** F31 (3 Series Sports Wagon)

Produced from **NEW** November 1, 2011 to November 28, 2013

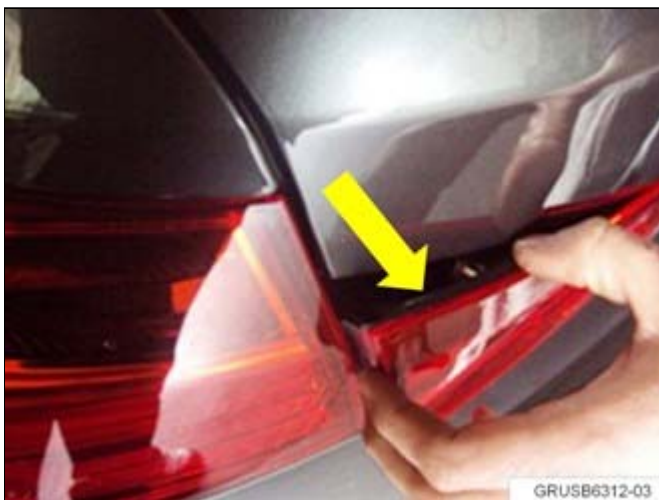
The customer may notice the taillight is either loose or protruding outward from the trunk lid.

The taillight is not attached to the trunk lid properly due to the taillight design.

1. **NEW** Confirm the customer complaint by checking both left and right rear taillights for looseness or protrusion. Shown is a loose left rear taillight. If a loose taillight is seen, the taillight must be replaced with the improved part listed below.

If a customer complains of this taillight issue, an improved part is now available.
