**SUBJECT****One or Both Headlights Are Aimed Downwards****MODEL**

F15 (X5)

F32 (4 Series Coupe)

Produced from July 01, 2013 to October 31, 2013

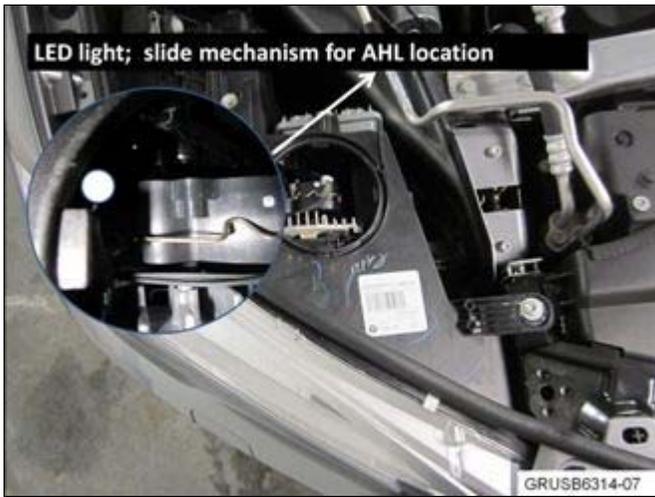
The picture shows the right side LED headlight. With the cover removed, on the left side you will see the slide mechanism all the way down. The

magnification in the picture highlights the approximate location.

For the left side headlight, the location is on the right side.

4. Set the light switch to the auto position.
5. Have someone turn the ignition on. At the same time, move the mechanism (highlighted in the pictures above) to free it with a long screwdriver.
6. Perform the same procedure on the other headlight, if needed.
7. After completing the self test, check faults and recheck operation.
8. Program the vehicle with ISTA/P 2.5.1.3 or higher. (Make sure the TMS-3 L and TMS-3 R are in the measure plan for coding.)

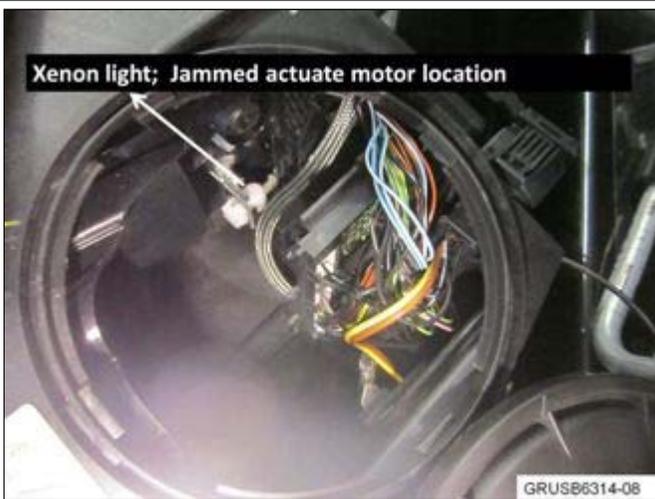
The picture is for right xenon headlight. With the cover removed, you will see the actuate motor.
Note: Make sure the cover is installed and tight to avoid water leaking or moisture entering the headlight.
