**Service Action: Replace Both Sun Visors**

R55 (Clubman)

R56 (Cooper)

R60 (Countryman)

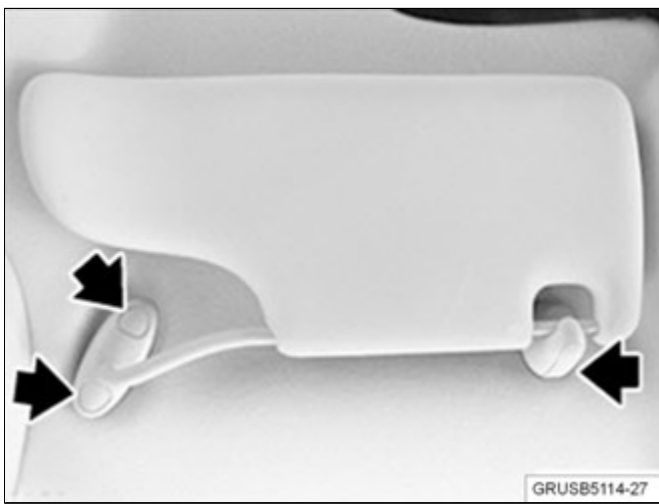
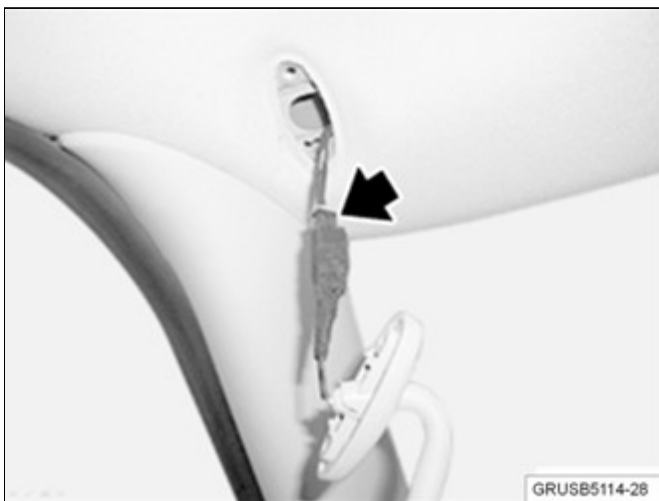
When opening the sun visor mirror cover, the pivot pins bind.

The spring tension is too great and weak pivot pins can break.

Replace both sun visors.

1. Release the covers and screws underneath.

Remove the sun visor and counter support.
