Rattling Noise when Closing Boot Lid

R59 (Cooper Roadster)

Produced from January 2, 2012

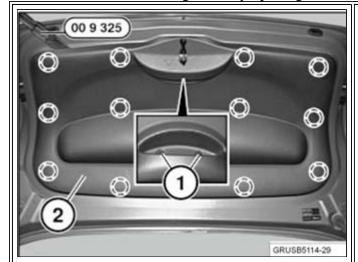
1. Open the boot lid and remove the boot inner trim panel by releasing the two screws (1).

Unclip the tailgate trim in the marked areas (2) with special tool 00 9 325. Remove the tailgate trim (2).

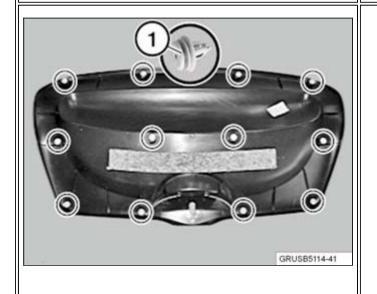
2. The securing clips lose their effectiveness after they are removed.

All twelve clips must be replaced to eliminate rattling noises.

Clips (1) must not be damaged.

Note: If the trim is removed for any reason all clips must be replaced.
