US 53055102-02

Gear lever does not return to the neutral position

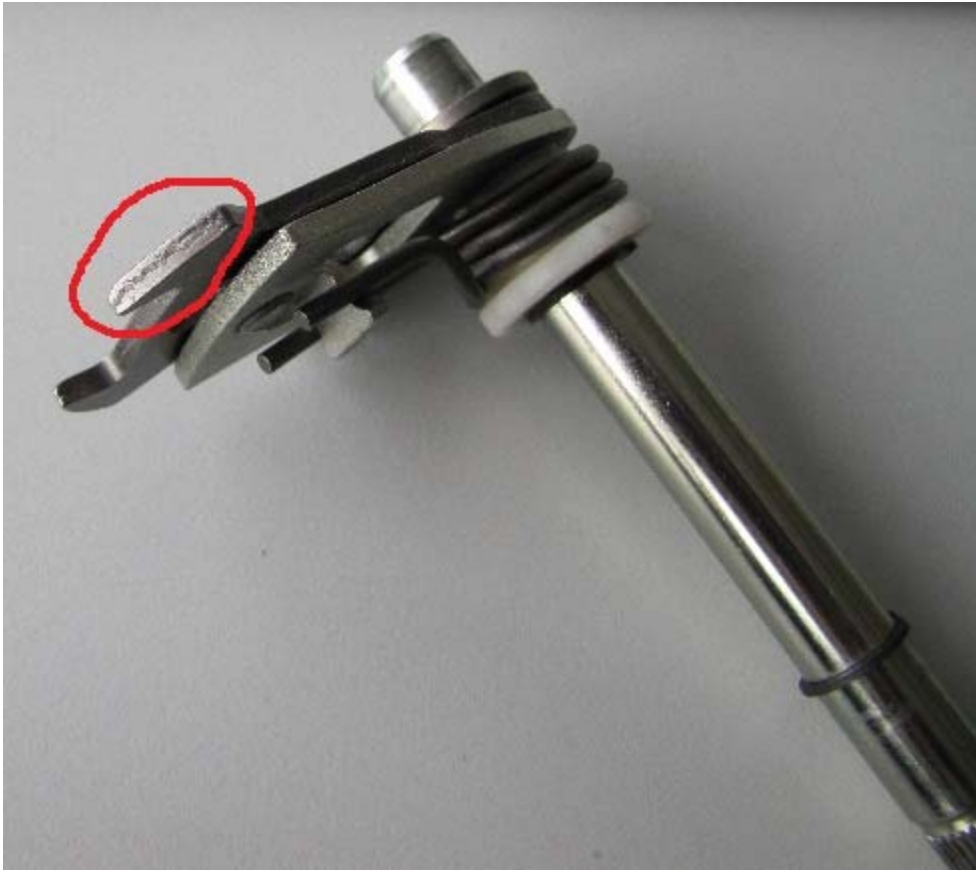
Two narrow faces on the shifting pawl (part of the selector shaft) may be too uneven.

The attached PICTURE shows one of these surfaces circled in red – the selector shaft shown is actually defect-free (!) because the surface only requires a load-bearing proportion of 50% (the condition of the deep part of the face is not important).

The second face section with virtually identical dimensions (approx. 15 mm long and 3 mm wide) is on the opposite side of the shifting pawl (at the bottom of the image).

The excessive unevenness sporadically causes the shifting pawl to remain stuck on the star wheel, which prevents the gear lever from returning to the neutral position.

Grooves running transversely over almost the entire edge width of 3 mm are critical.

Removing the selector shaft (depending on the model, current part numbers 23007690384 or 23007706750).

1. Smooth both face sections. Please note that the actual "hook height" at the tips of the pawl must not be decreased, as the pawl will otherwise not reach over the pins of the switch wheel.

PLEASE NOTE: These functional faces need only have a load-bearing proportion of 50% with a smooth surface; lower-lying portions with a rough surface are present for reasons related to manufacture.

2. Fit new part.
