US 57242219-01

Bench seat cover is wavy

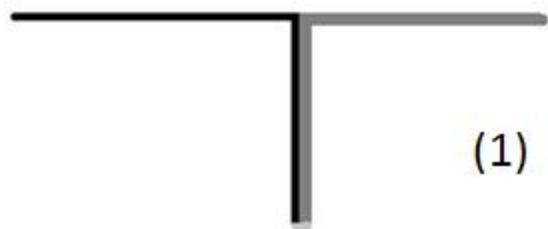
Cover of bench seat is wavy. See 1st picture.

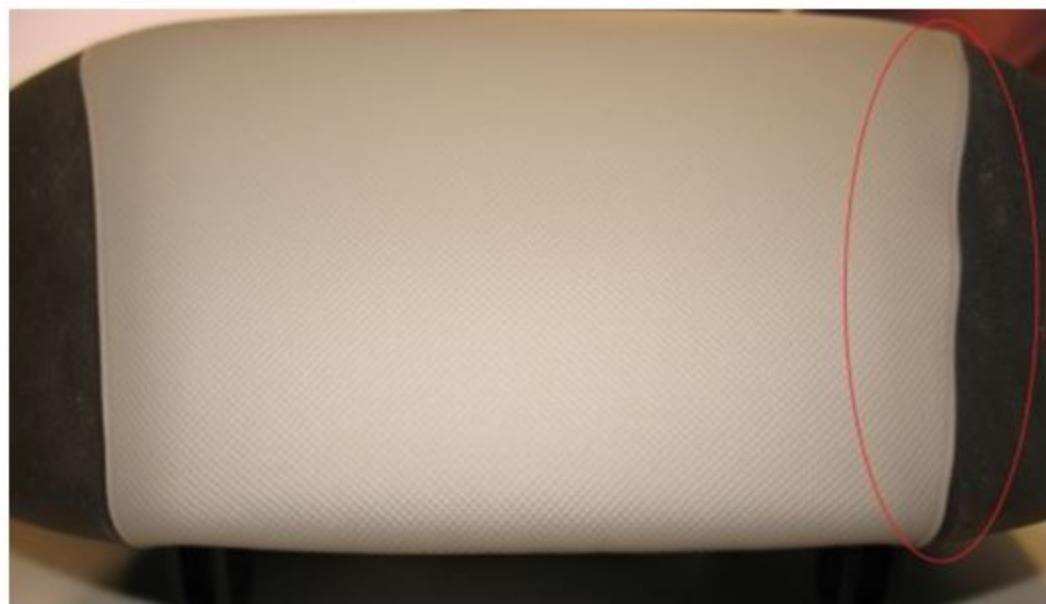
The various colors of the bench seat cover are sealed together and then folded, see (1) and (2) in 2nd picture. If this is twisted, the cover may be uneven (3).
