This Service Information bulletin **replaces SI B12 18 12 dated November 2012.**

N63: Proper Ignition Harness Installation and Ground Connections

All with the N63 engine

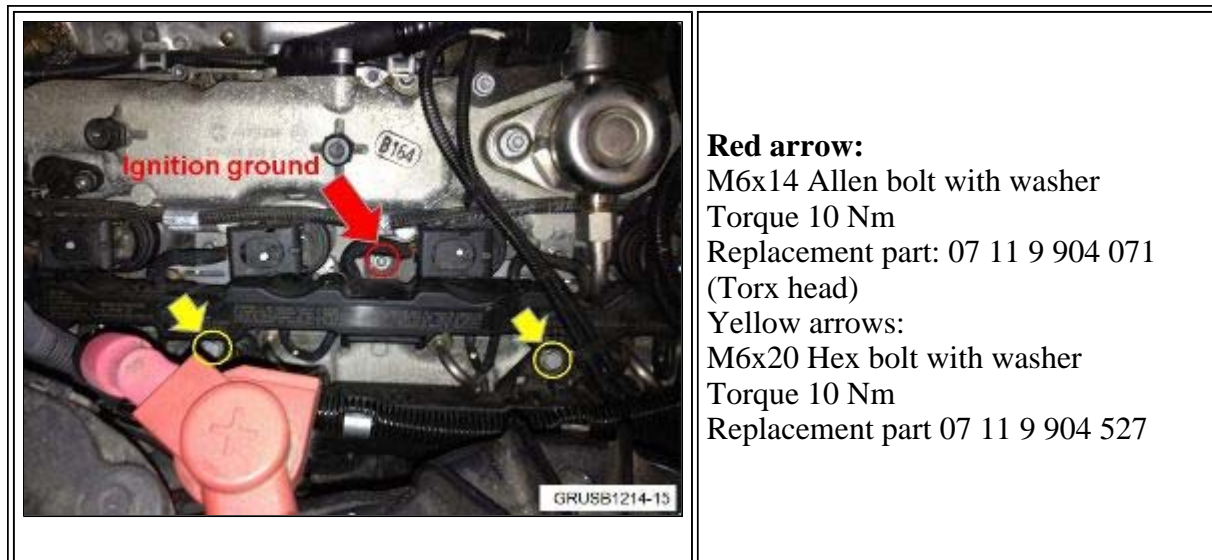
Any of the BSD interface components could be damaged immediately upon engine start if the ignition ground circuit, integrated into the metal bushing of the ignition coil harness duct on both cylinder banks, is not secured to the engine cover with the correct bolt and to the specified torque.

This crucial ground point location is indicated with the **red** arrow in the picture below.

It is absolutely essential that during any engine repairs which require loosening or removing of the engine harness, special attention be paid during reassembly to ensure the ignition coil harness bolts are the correct part and are tightened to the specified torque before attempting to start the engine.
