Service Action: Replace Fuel Tank Pressure Sensor

I01 (i3 REx)

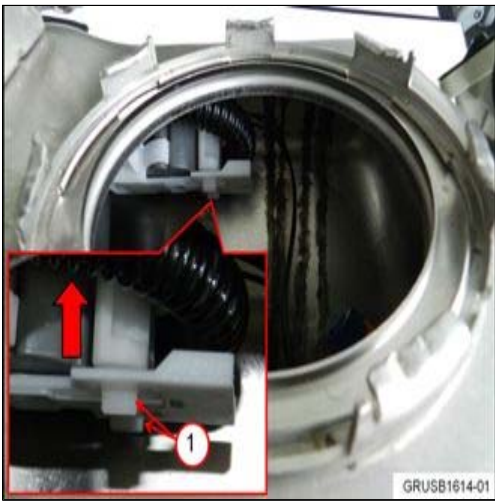
The internal sealing of the fuel tank pressure/temperature sensor may fail. As a result, the sensor may read an incorrect value and set a fault code for the fuel tank evaporation system. This may lead to the Check Engine Light (CEL) being illuminated.

| | <ol style="list-style-type: none"> 4. Remove the pressure sensor by pressing the tabs (1) at the base of the sensor together and pushing up in the direction of the arrow. This will separate the pressure sensor from the |

retaining bracket.

5. Install a new pressure sensor from the Pressure Sensor Repair Kit (P/N 16 14 7 426 661) in the reverse order of the pressure sensor removal. Also install the new O-ring and the support ring which are found in the repair kit.
