### Door Opens to First Stage While Driving

F15 (X5)

Produced from June 30, 2013

With option 323 (Soft Close)

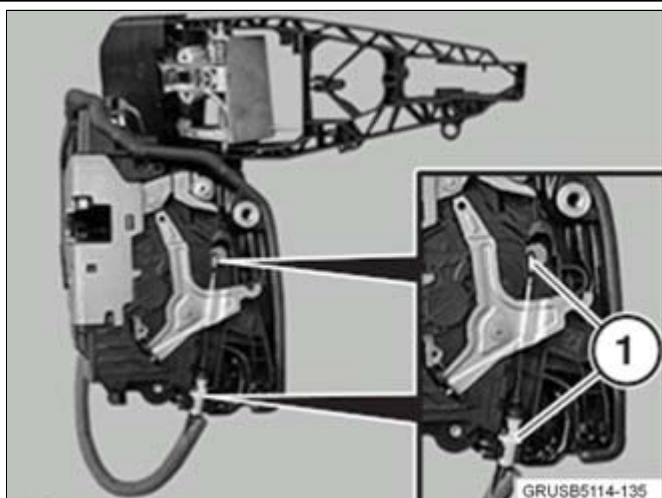
### 18. Disconnect the Bowden cable (1) and remove the door lock.

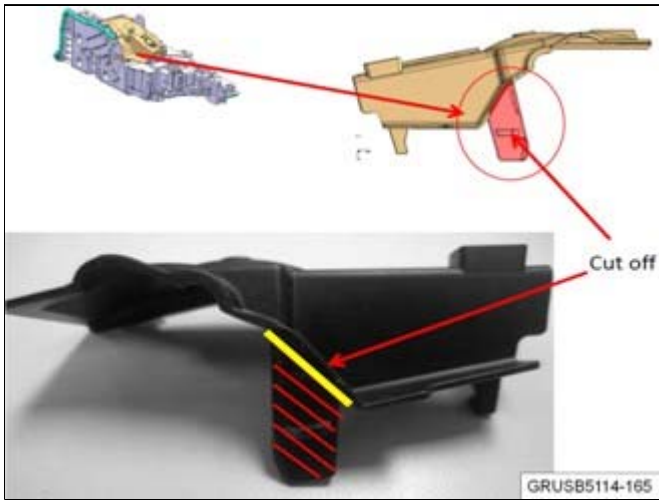
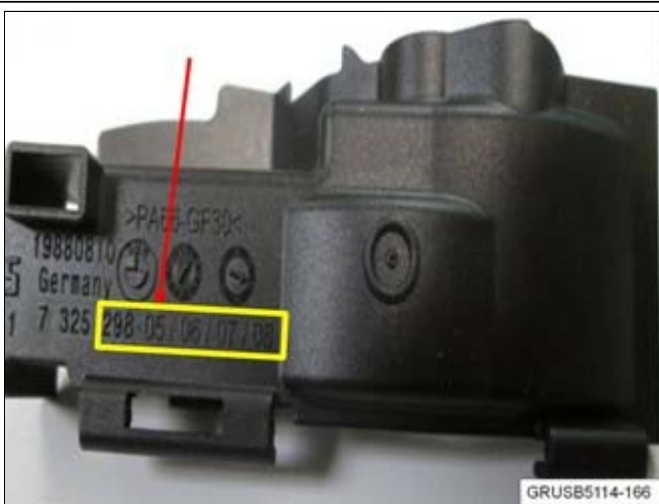
### 19. Remove the existing Bowden

cable cover from the lock and discard.

Check the date code on the door lock to see if it needs to be replaced as well. See step 21 below.

Modify the new Bowden cable cover by cutting off the guide tab (as shown) with a suitable tool (diagonal cutters, wiz wheel, etc.).

Complete the same procedure for the remaining three door locks.

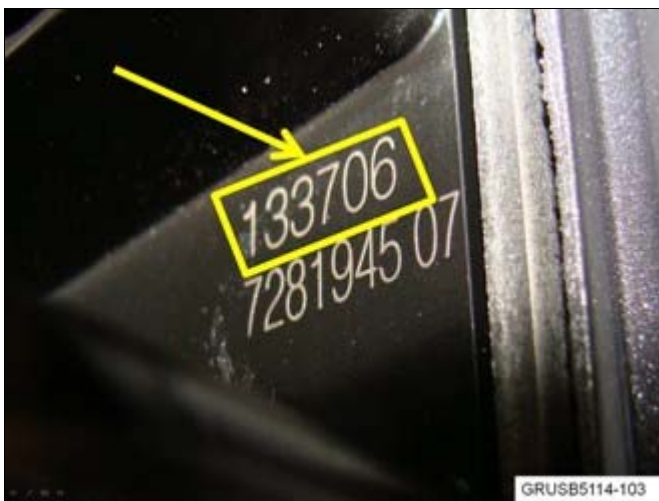
20. Note: The date code on the new Bowden cable cover must be 05 or higher.
