Service Action: Check Door Pull Trim and Replace if Needed

F80 (M3 Sedan)

F82 (M4 Coupe)

Produced from March 18, 2014 to May 7, 2014

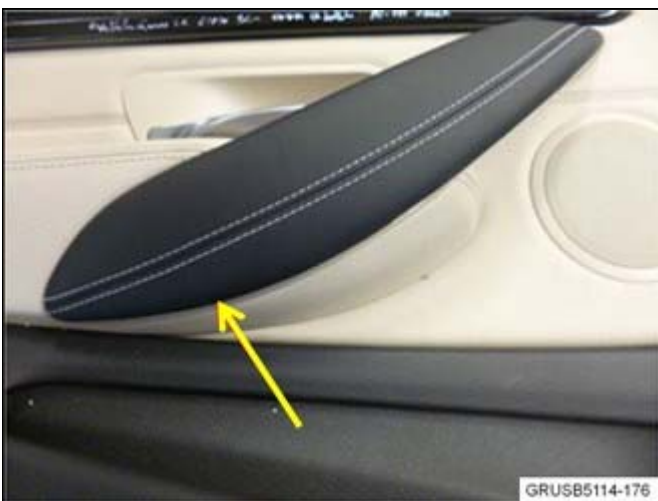
<ol style="list-style-type: none"> 1. Check the lower catch locking by pulling on the trim at the location shown. <p>Note: Do not use any tools. Only use your fingers to determine if the trim is locked correctly.</p>
--	--

If any of the trims can be detached by hand without the use of tools, they must be replaced.

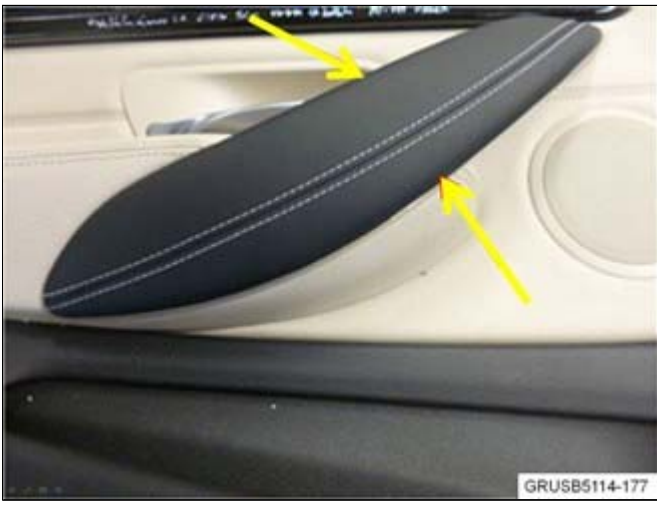
2. Check the center catch locking by pulling on the trim at the locations shown.
