SUBJECT

Door Mirror Wind/Whistle Noise

E84

F30

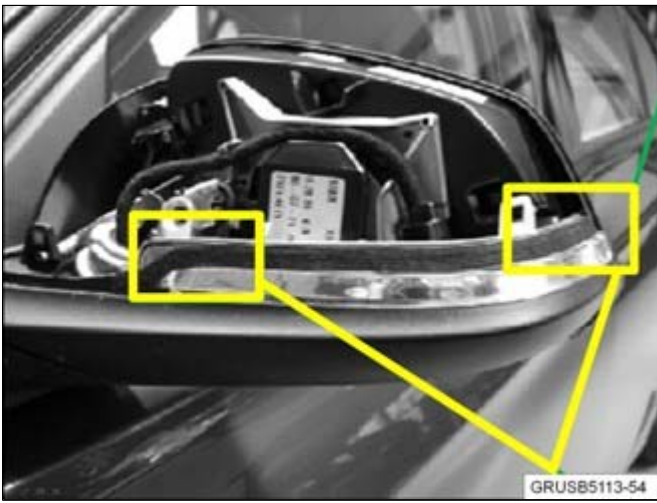
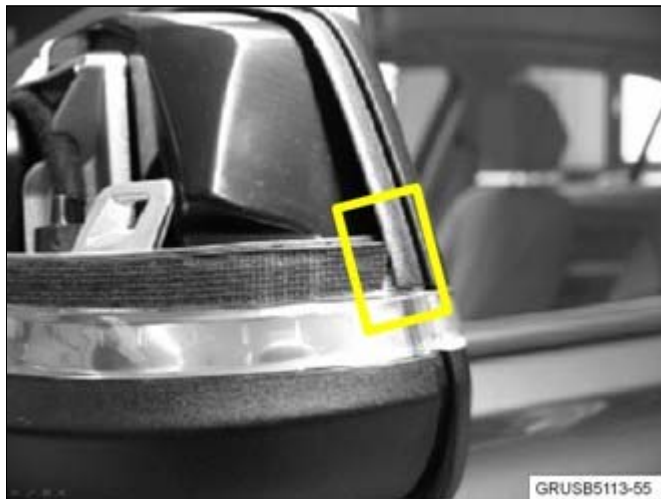
<ol style="list-style-type: none"> 4. Clean the entire upper surface of the turn signal housing with a clean cloth. Caution must be used when applying the tape in the areas shown.
--	--
