Service Action: Replace Engine Compartment Sound Insulation

F80 (M3 Sedan)

F82 (M4 Coupe)

Produced from March 18, 2014 to May 20, 2014

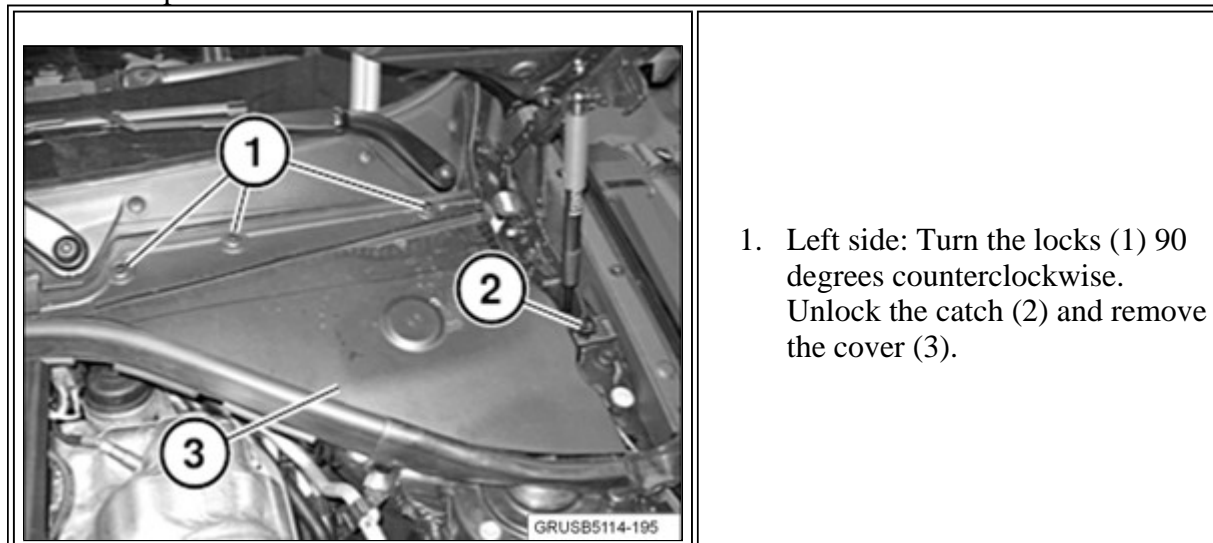
1. Left side: Turn the locks (1) 90 degrees counterclockwise. Unlock the catch (2) and remove the cover (3).

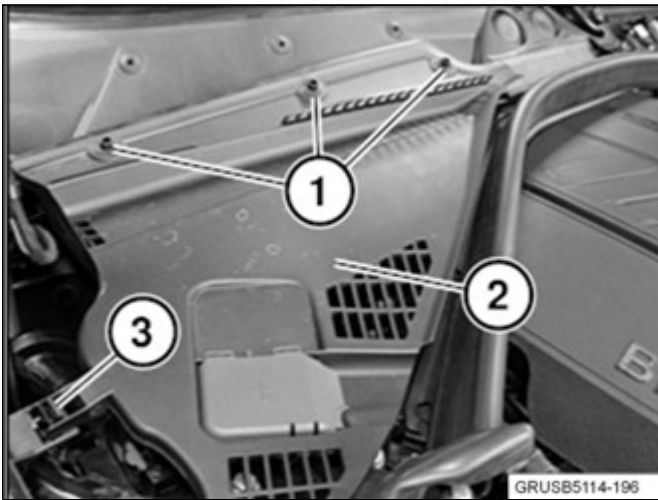
2. Right side: Turn the locks (1) 90 degrees counterclockwise. Unlock the catch (3) and remove the cover (2).

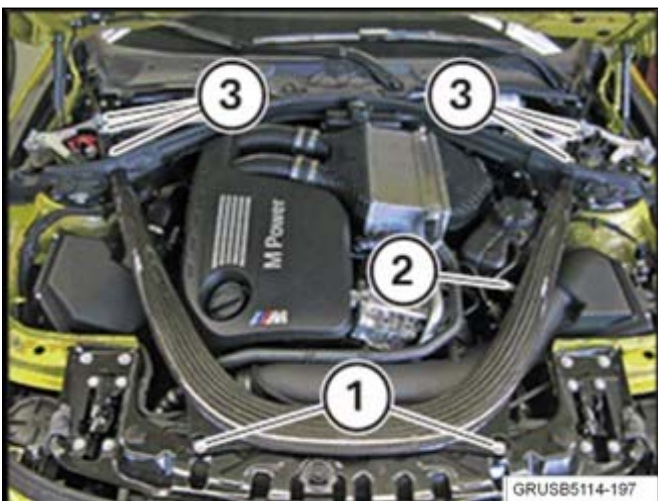
3. Remove the screws (1, 2 and 3) and feed out the carbon strut.

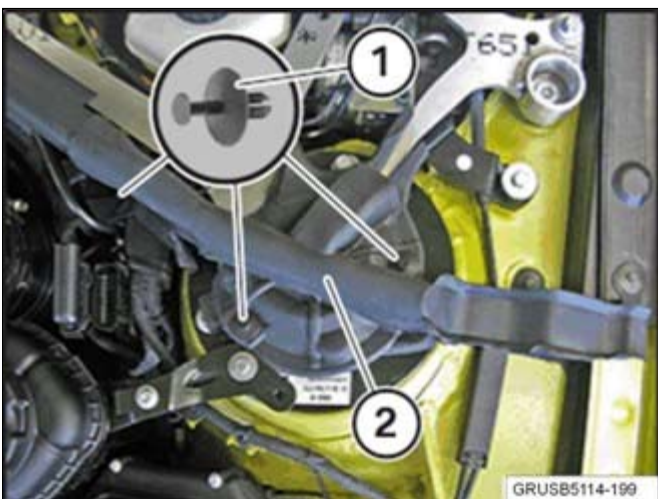
4. Remove the expanding rivets (1). Place the sealing (2) back.

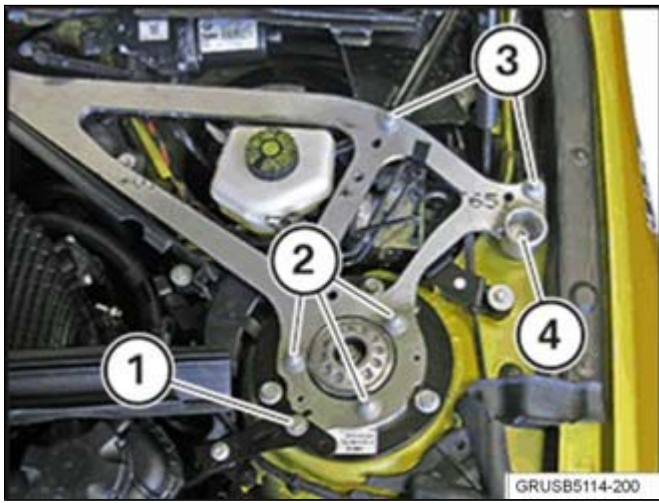
5. Remove the screw (1) and holder for the expansion tank from the tension strut.

Remove the screws (2, 3 and 4).

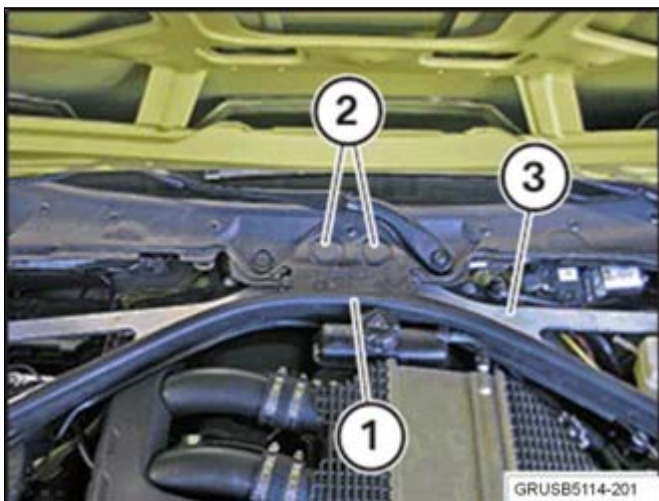
6. Pull off the seal (1).

Release the covers (2) and remove the screws underneath.

Remove the tension strut (3).

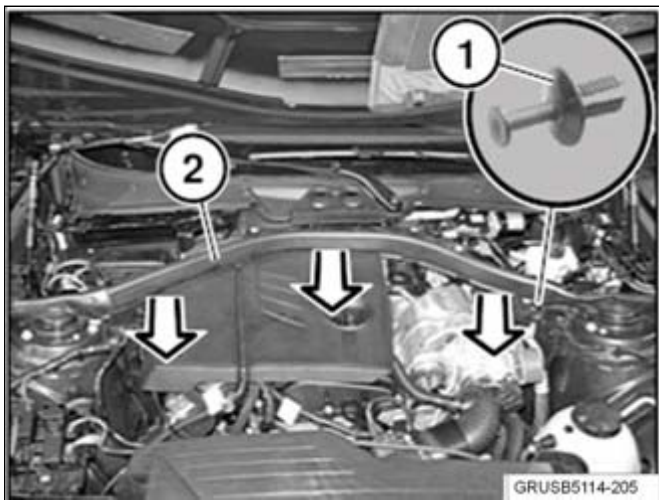
7. Release the expansion rivet (1).

Unclip the seal (2) in the direction of the arrows.

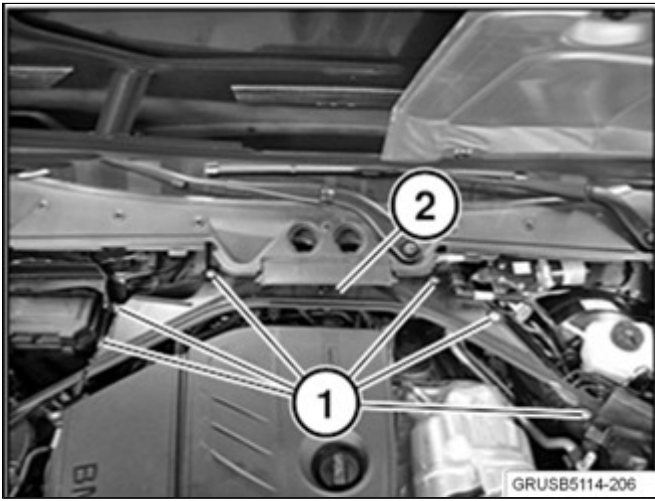
8. Remove the screws (1).

Feed out the sound insulation from the upper part of the bulkhead (2) and replace the sound insulator.

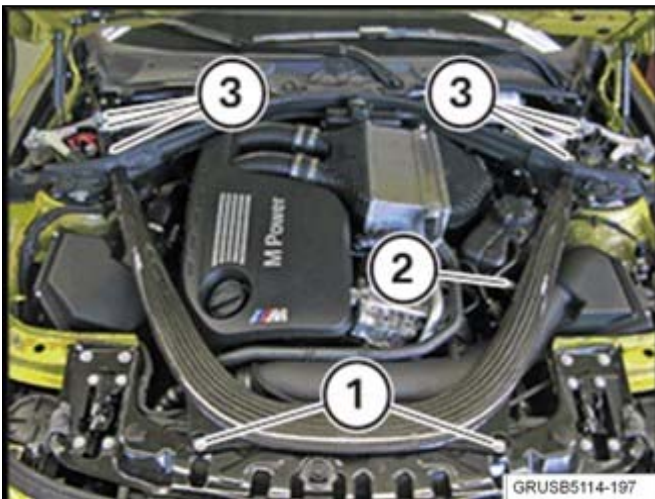
The gasket at the bottom of the sound insulation of the upper part of the bulkhead (2) must not be damaged.

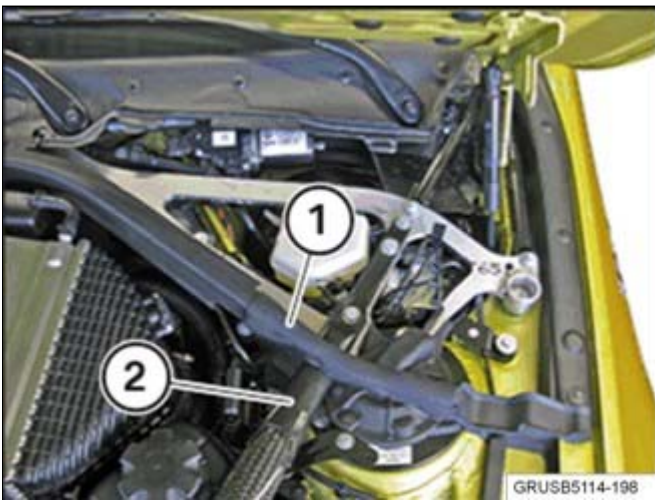
9. Feed in the carbon strut.

Tighten down the screws (1).

Tightening torque is 28Nm.

Tighten down screw (2) then tighten down the screws (3).

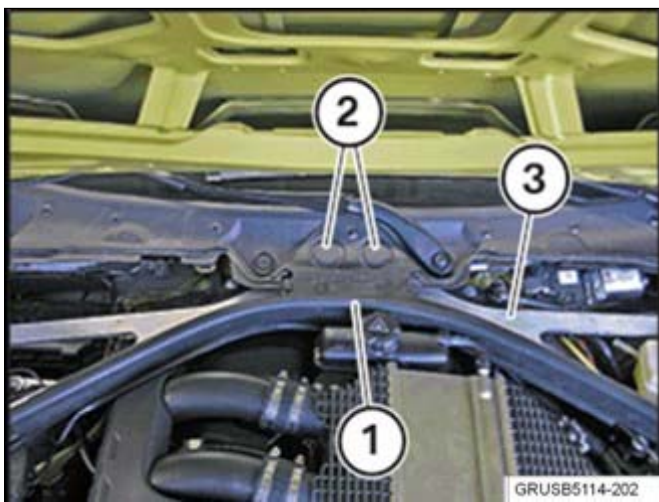
10. Make sure the seal (1) fits correctly on the left and right carbon strut (2).

11. Insert the tension strut (3).

Tighten the screws under the covers (2).

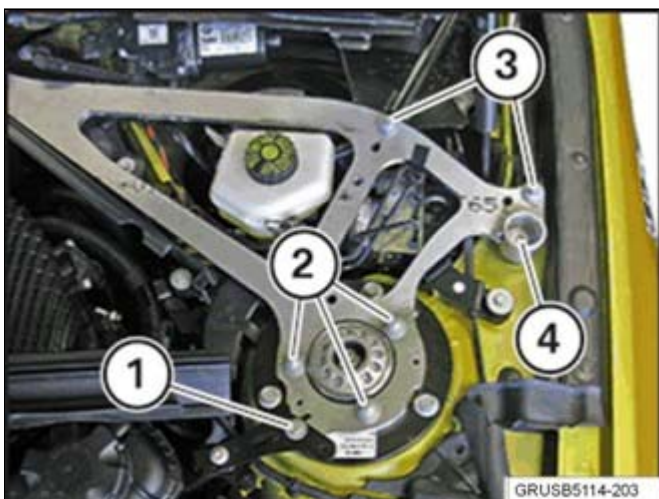
Tightening torque is 56Nm.

Install the covers (2).

Attach the seal (1).
